**Geophysical Surveys Near  
Tucson International Airport**

**Geophysics Field Camp 2013  
LASI-13-1  
May 15, 2013**

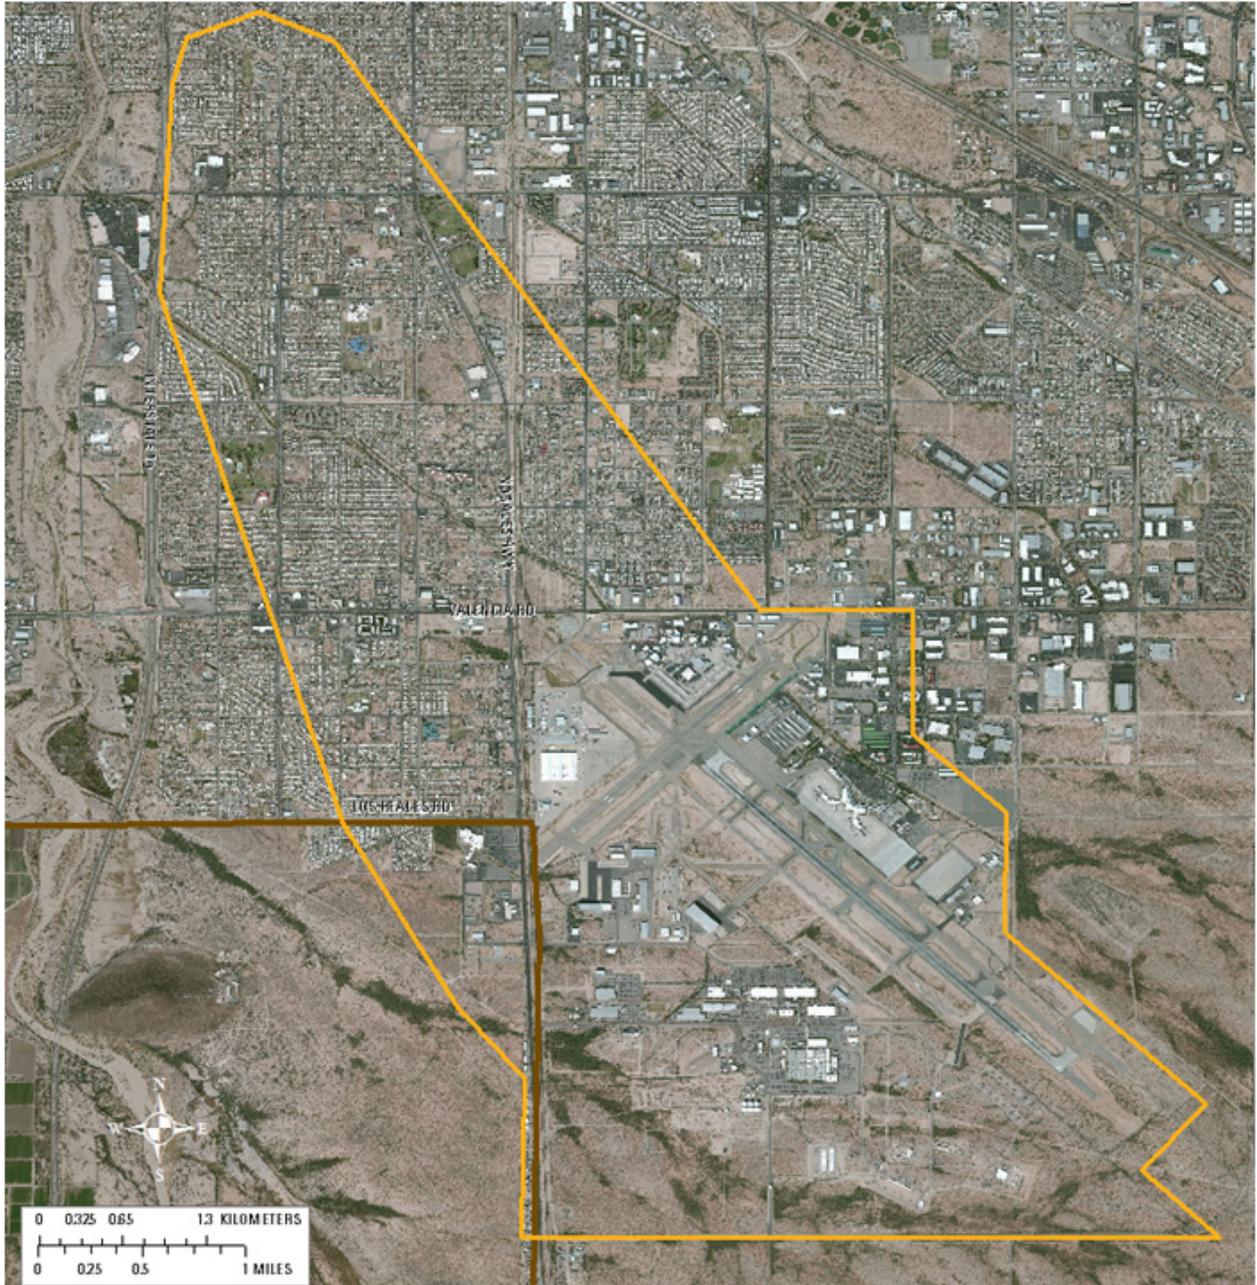
**Figure 1.1:** Aerial map showing the Superfund site (contained in the polygon). Courtesy of Fred Tillman, USGS (2013).

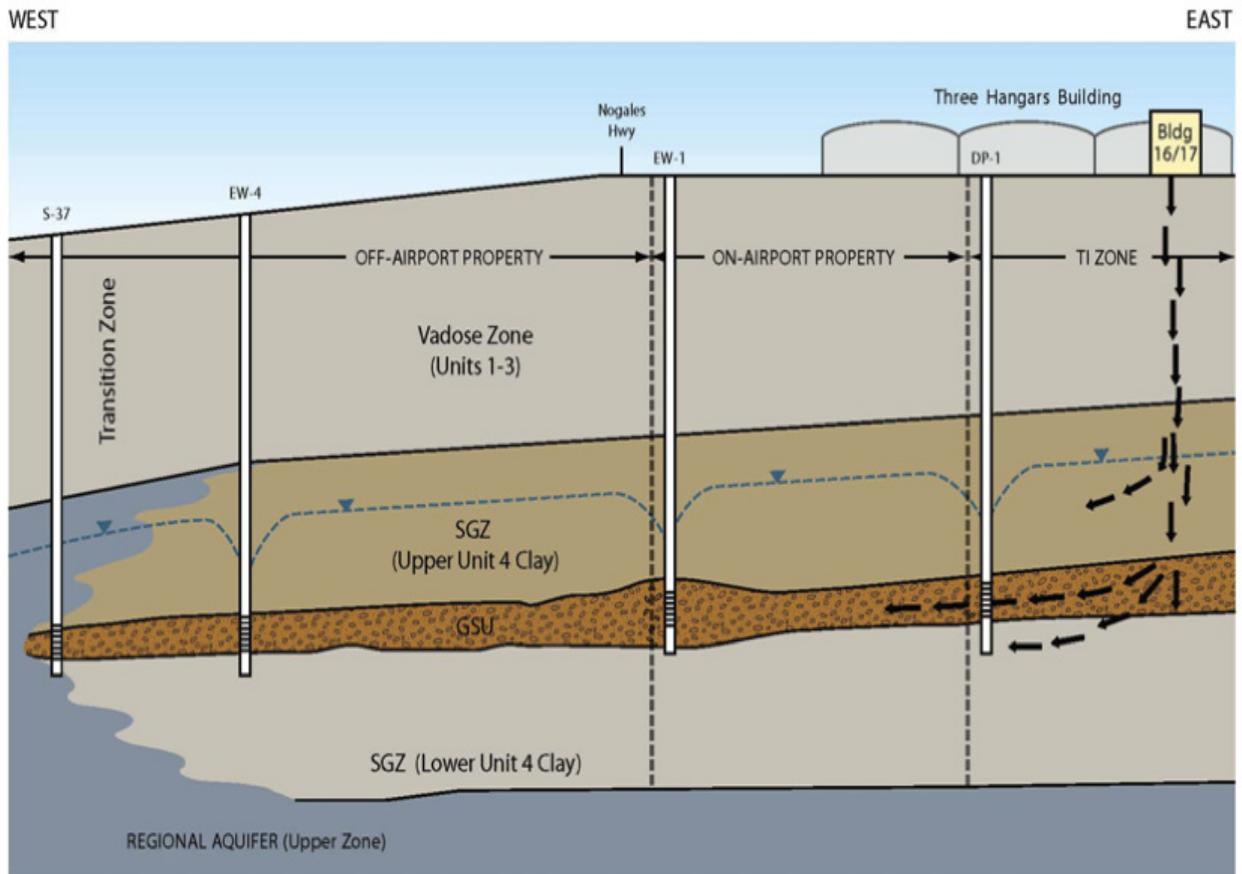
**Figure 1.2:** Cross-sectional schematic showing the hydrogeological sections and general flow of contamination plume (depicted by arrows) (Conestoga-Rovers and Associates, 2012).

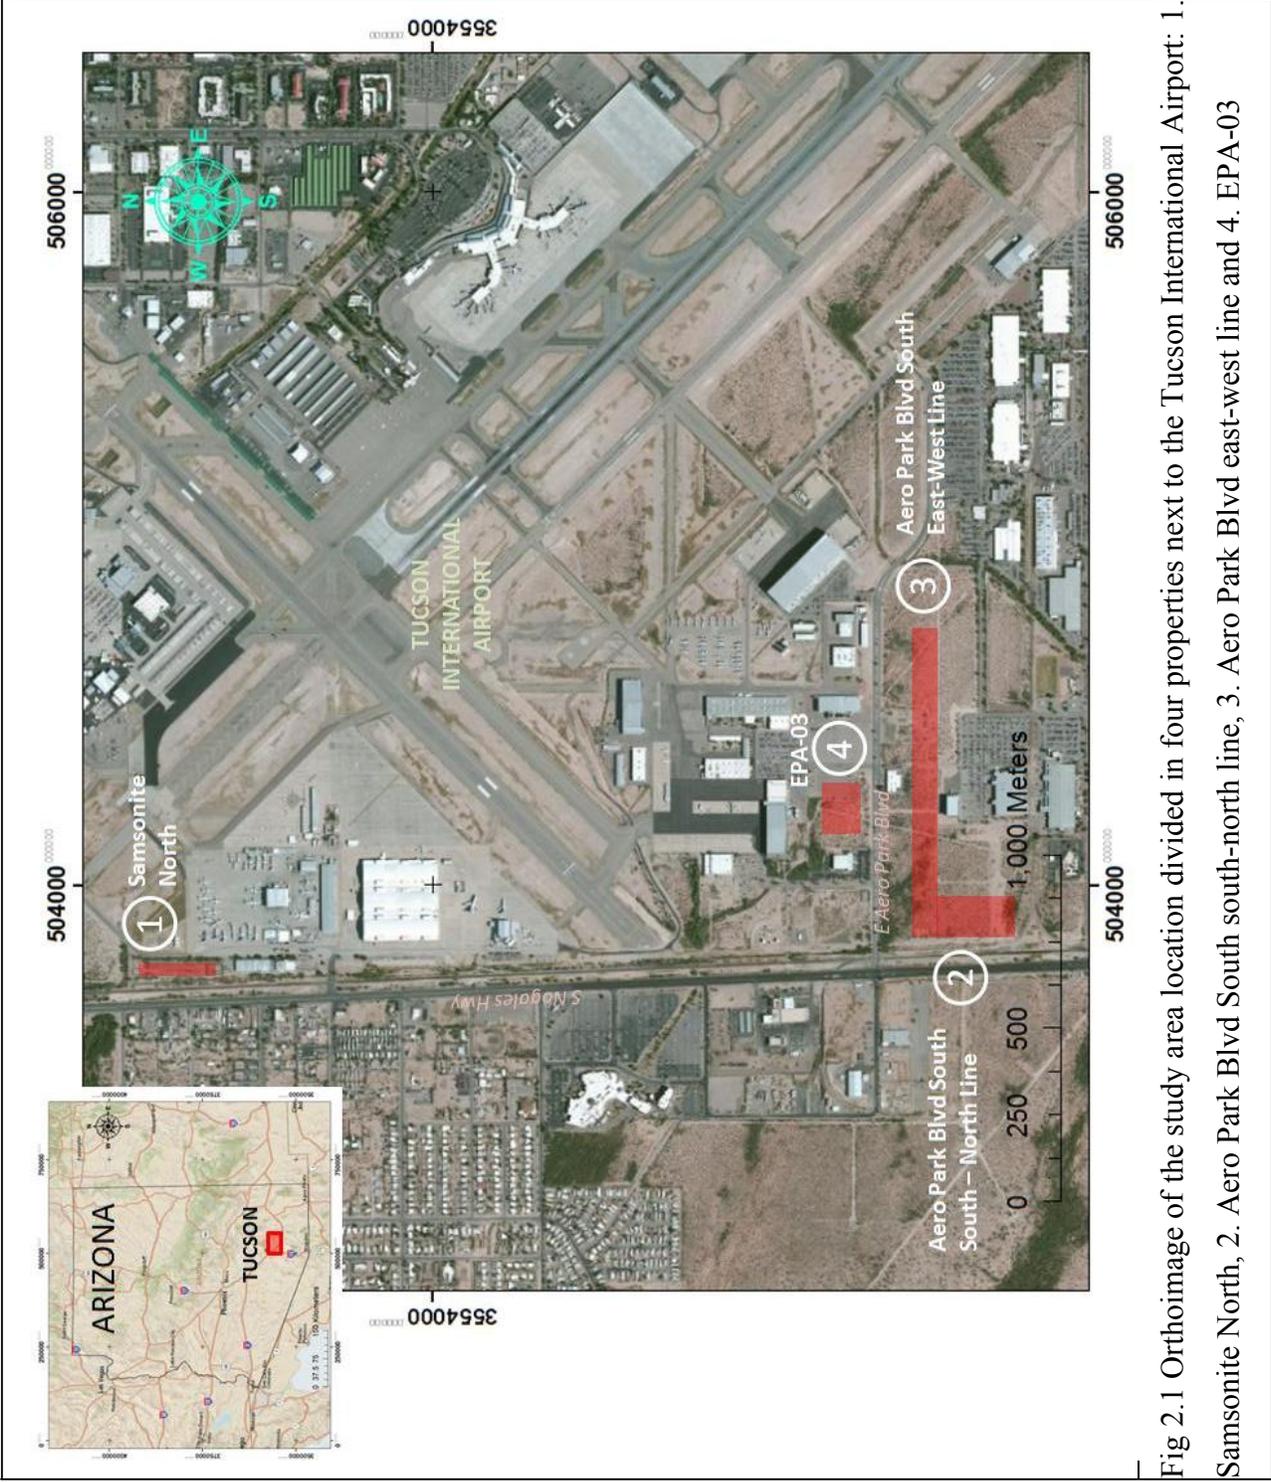
Fig 2.1 Orthoimage of the study area location divided in four properties next to the Tucson International Airport: 1. Samsonte North, 2. Aero Park Blvd South south-north line, 3. Aero Park Blvd South east-west line and 4. EPA-03

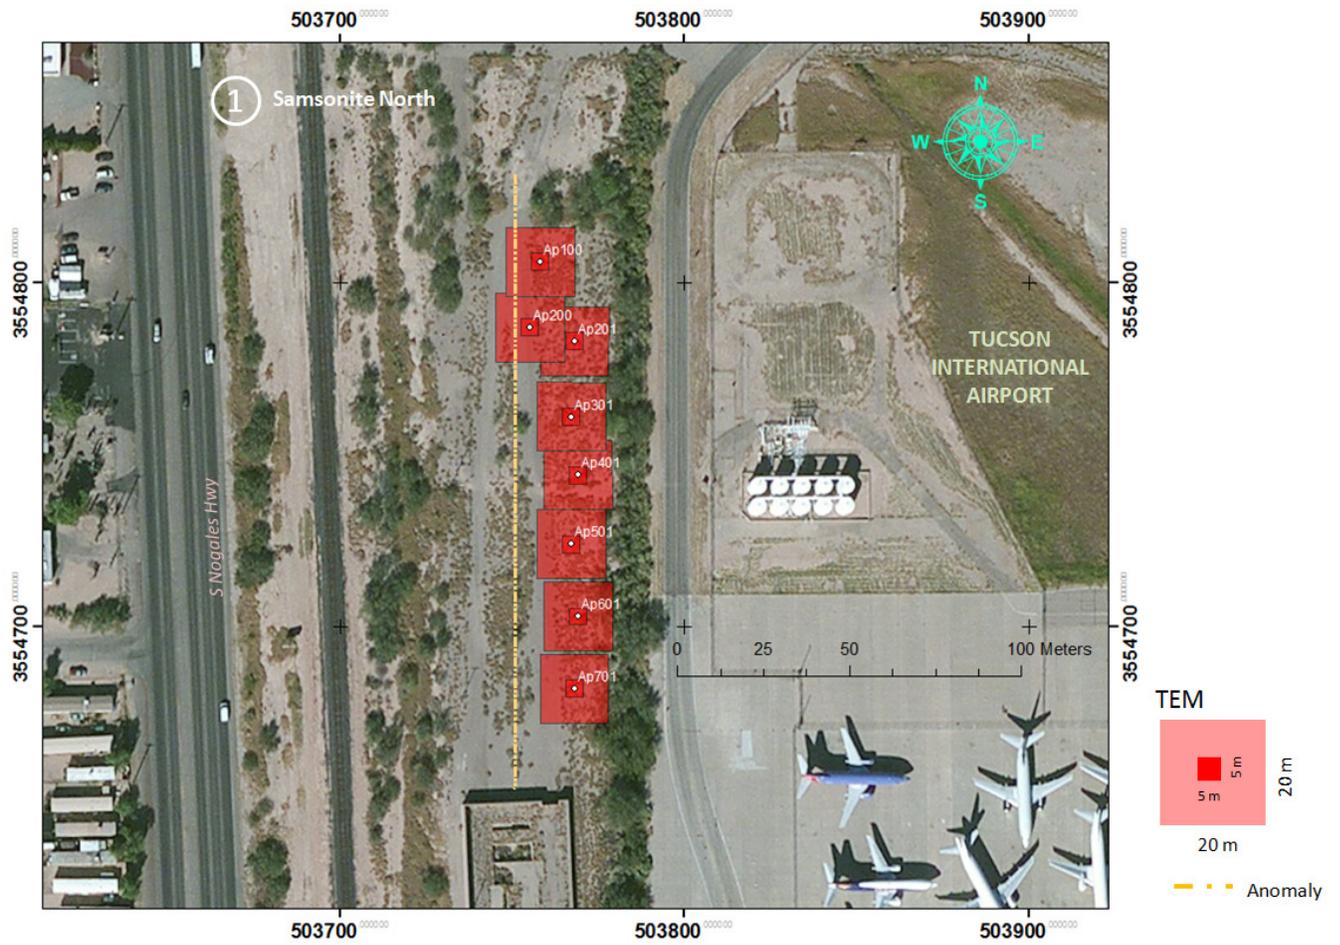
Fig 2.2 Eight 20 m x 20 m TEM loops at the Samsonite North site and anomaly detected in the field with a Fisher TW-6 metal and pipe detector (yellow line).

The coordinates of the 20m x 20 m loops' centers can be found in Tables A.1 and A.2. At the property Samsonite North (1) we used 8 loops. Along the Aero Park Blvd south-north line we used 9 loops and at the east-west line 23 loops. The EPA-03 site was surveyed with 5 loops (Figure 2.2 - Figure 2.5).

At the Samsonite north site, approximately 10 m towards the west from the TEM 20 x 20 m loops, we located an anomaly detected by a Fisher TW-6 metal and pipe detector. This anomaly had a south-north orientation and it was not found in the general water supply and sewage system maps (Figure 2.2). At the Aero Park Blvd south-north line there are water pipes running along a south-north direction at a distance larger than 30 m from the 100m loops border. At the Aero Park Blvd east-west line water pipes run beneath the loops 24100 and 25100 and approximately 10 m south from loops 26000, 27000, 28000 and 29000 (Figure 2.4). At the property (4) EPA-03 no cultural interference was mapped within the area surveyed.

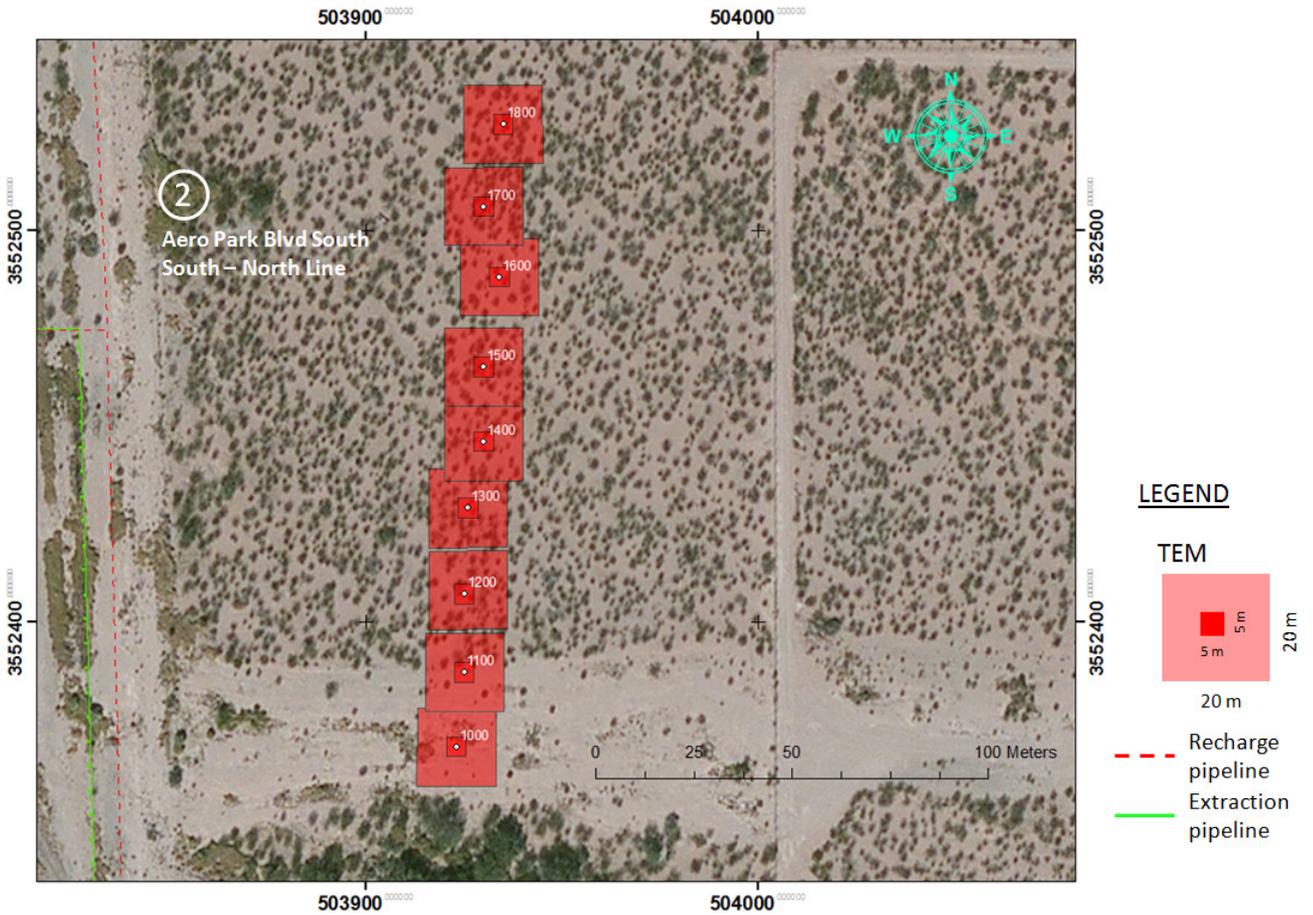
Fig 2.3 Nine 20 m x 20 m TEM loops at the Aero Park Blvd South: South-North line.

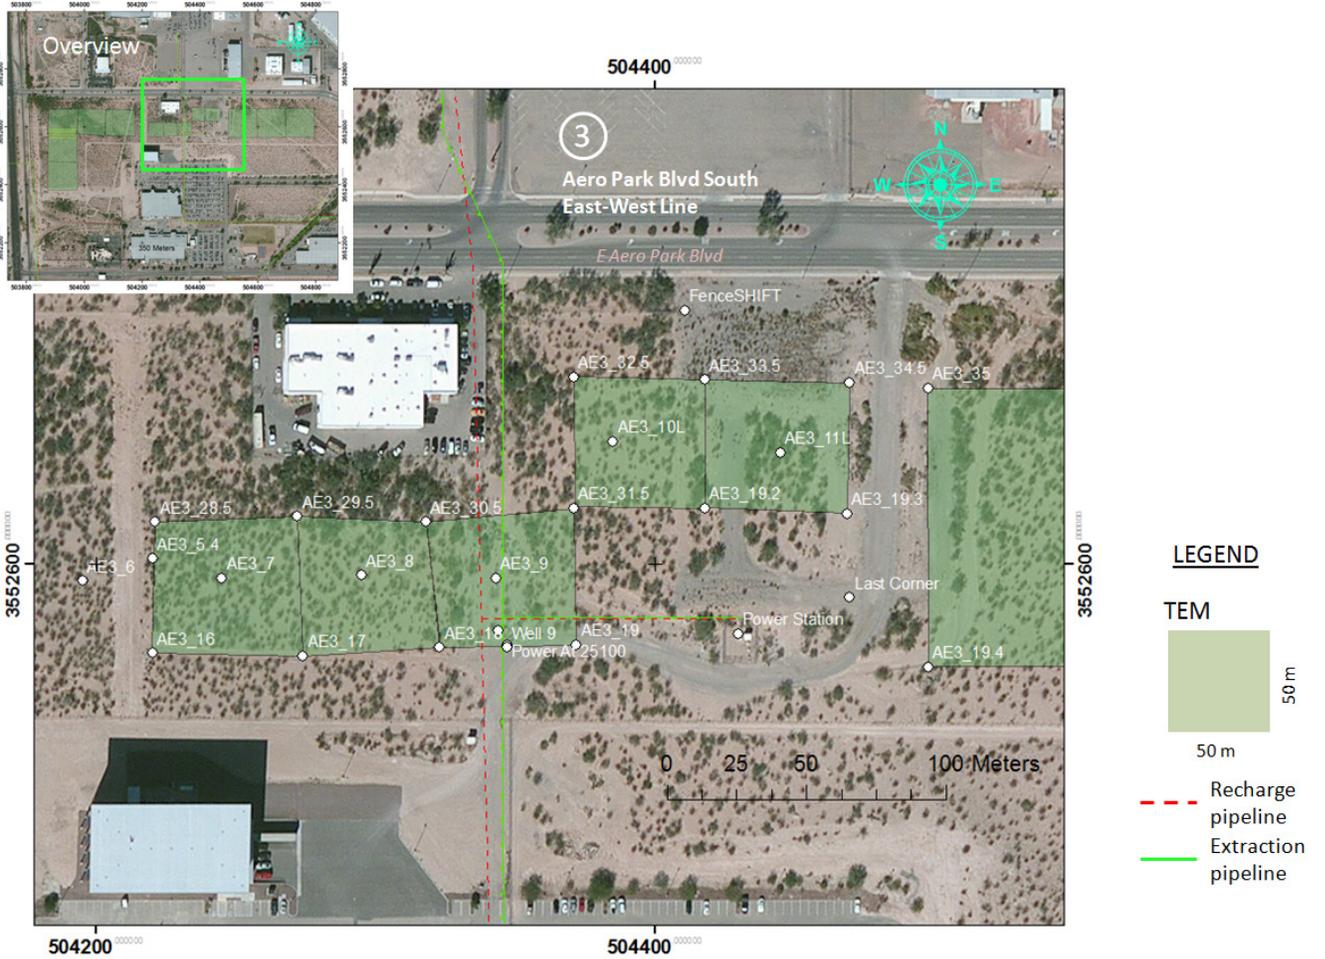
Fig 2.6 Five 50 m x 50 m TEM loops at approximately the center of the Aero Park Blvd east-west line.

Five 50 x 50 m loops were used at approximately the center of the Aero Park Blvd east-west line instead of 100 x 100 m loops because of limitation of space to complete 100 m loops (Figure 2.6). The coordinates of the 50m x 50 m loops' centers can be found in Table A.3.

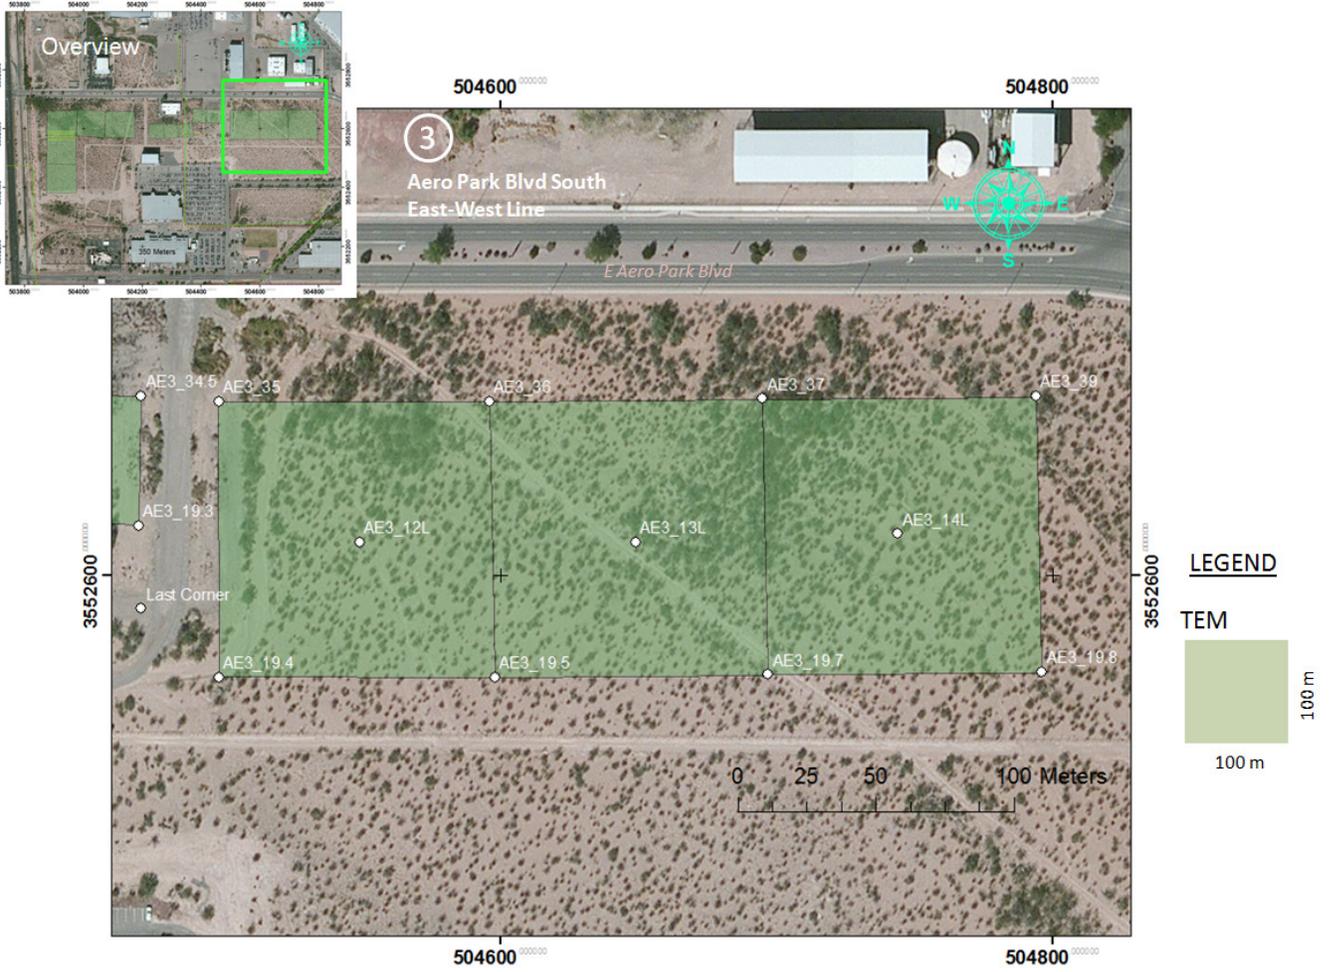
Figure 2.8 100 m x 100 m TEM loops at the Aero Park Blvd east-west line.

100 m loops were used in three out of the four surveyed properties. Three 100 x 100 m loops were used along the Aero Park Blvd south-north line. Six loops along the east-west line and one loop at the EPA-03 property. The coordinates of the 100m x 100 m loop centers and corners can be found in Tables A.4 and A.5. (Figures 2.7 - 2.9)

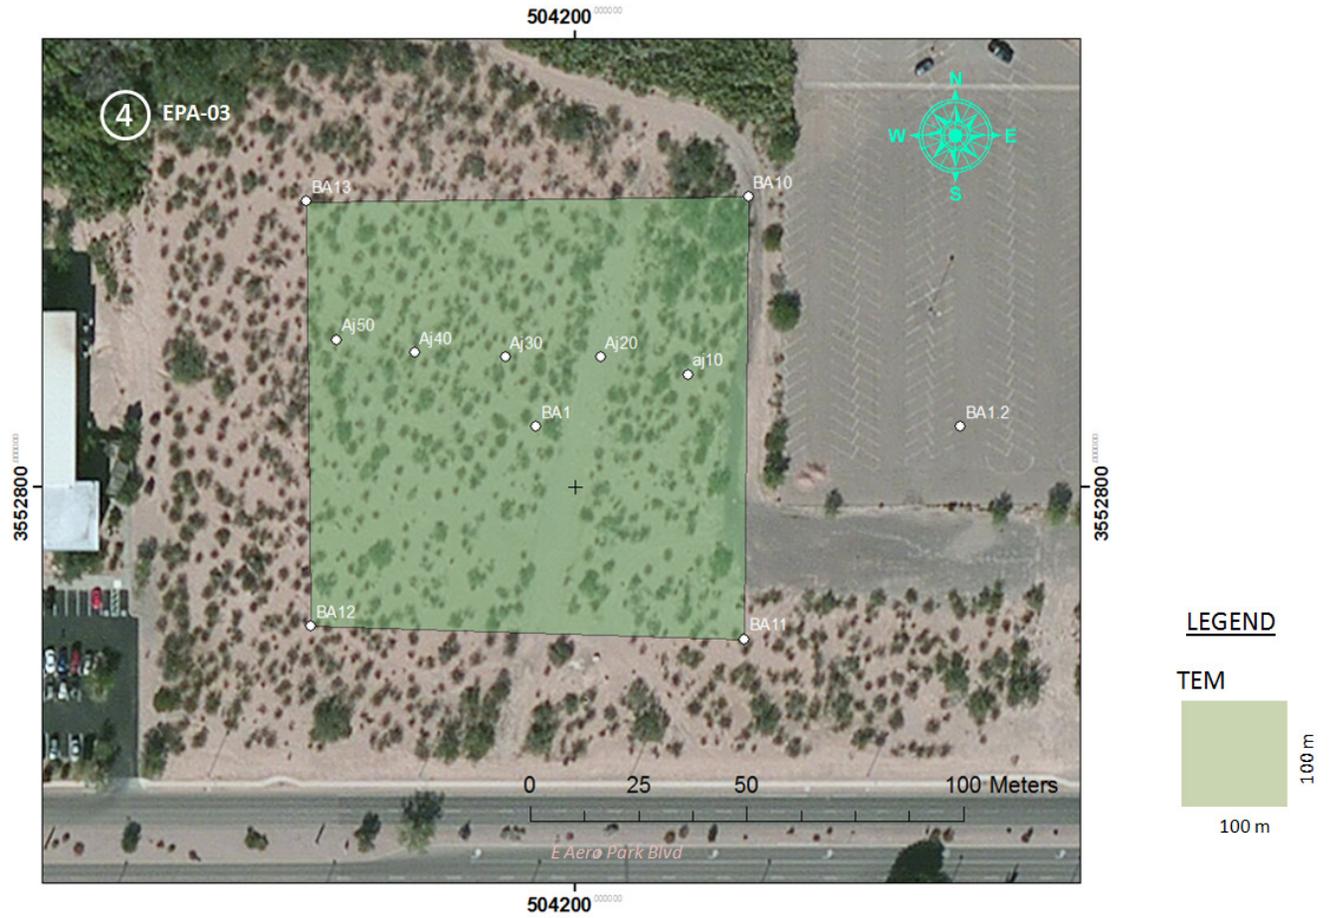
Figure 2.9 100 m x 100 m TEM loop at the EPA-03.

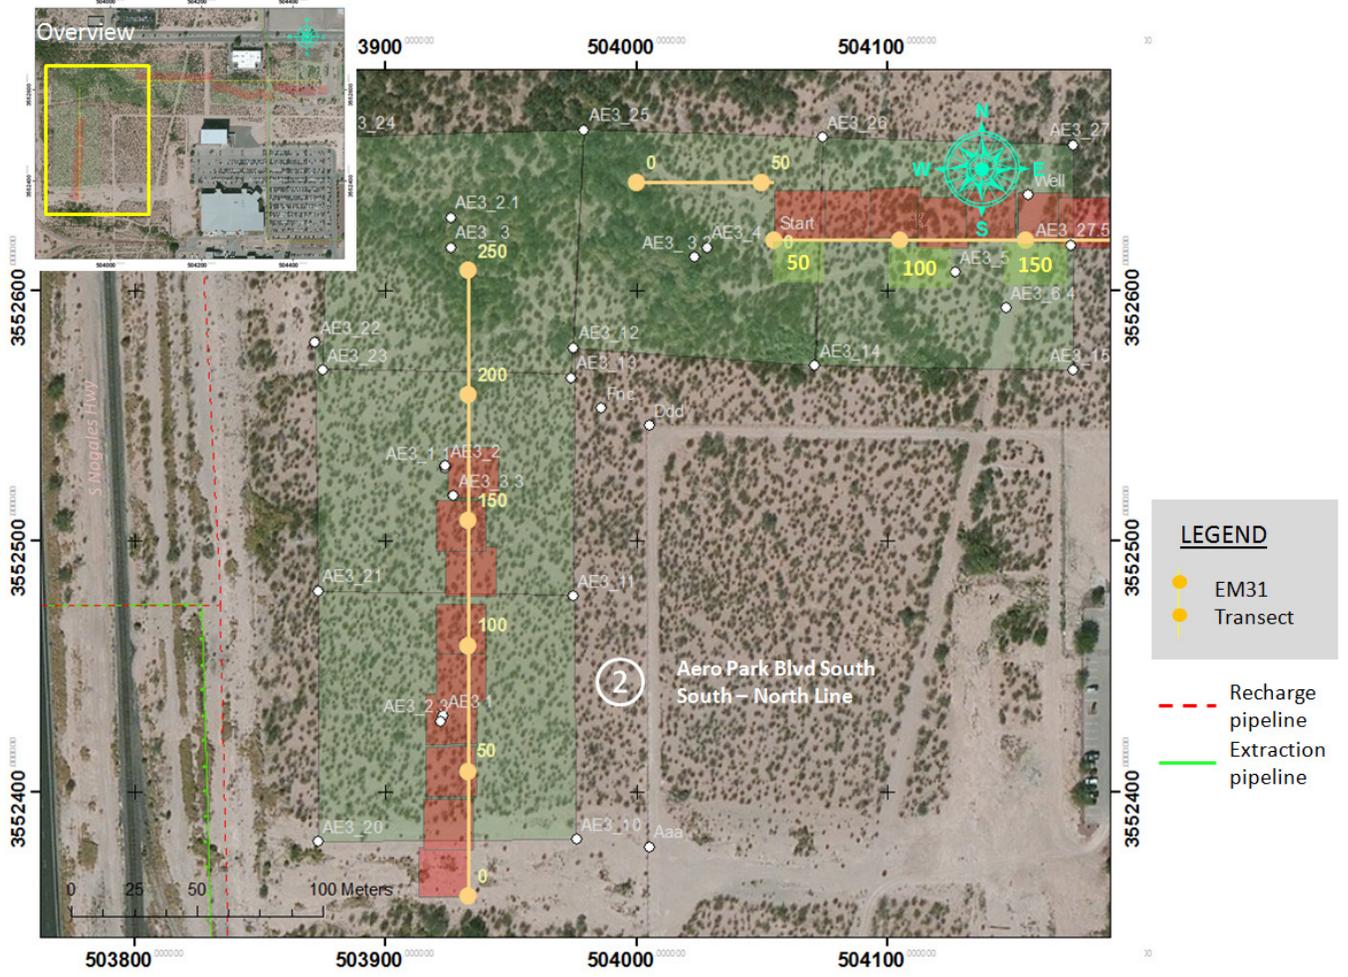
Figure 2.10 EM31 transect along the Aero Park Blvd south-north line and western part of the Aero Park Blvd east-west line.

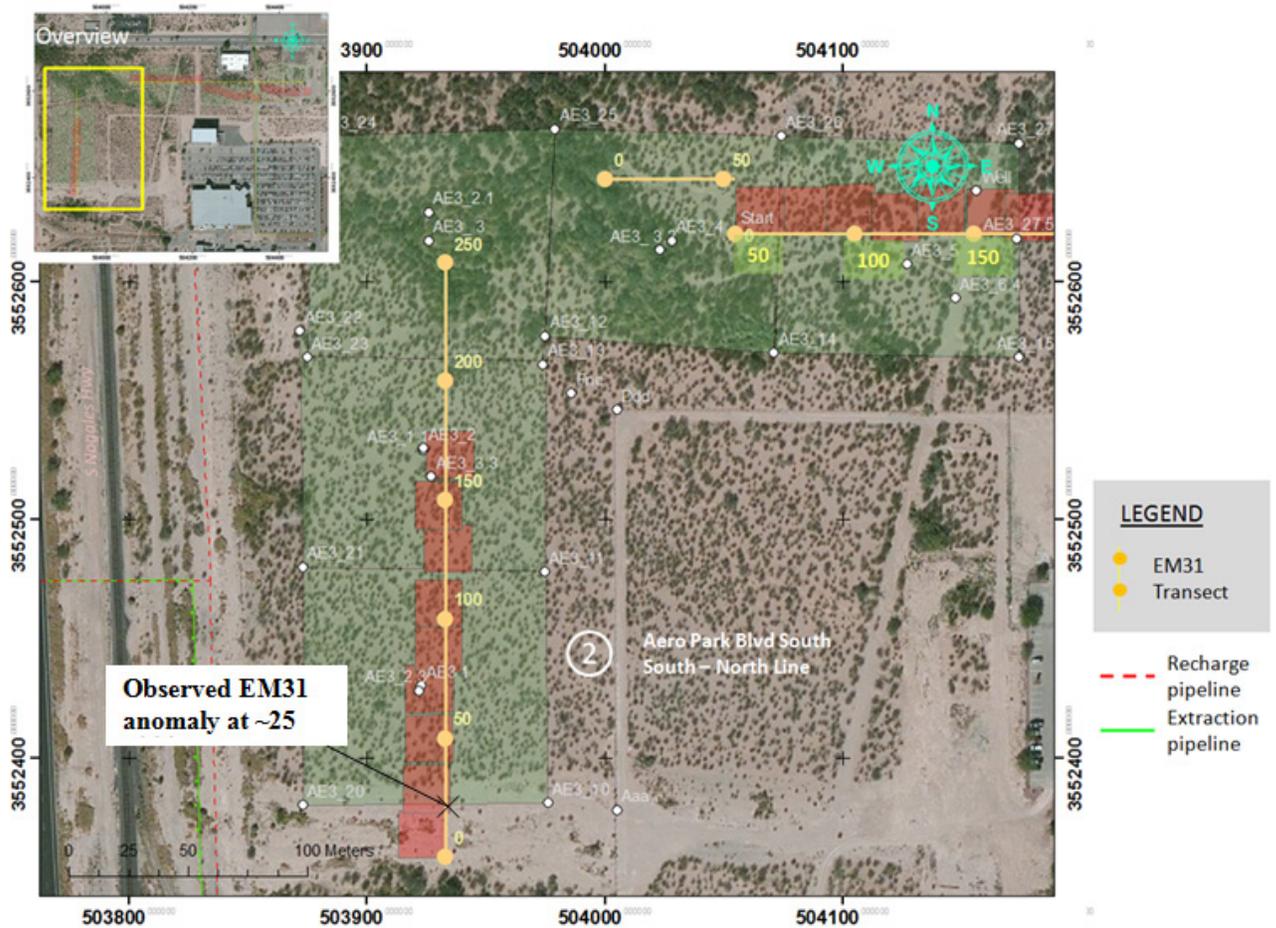
Figure 3.11: Map displaying observed anomaly at approximately 25m on the Aero Park Blvd N-S Line. This anomaly does not correlate with any visible pipe or power lines.

Such environmental observations included a utility access hole near the beginning (around 20-30 meters) of the North-South Aero Park line, which was located about 40 meters away and corresponds to a positive anomaly in that conductivity data set. Another utility access hole was observed on the West-East Aero Park line at 360 meters, which read “POWER LINES.” This observation corresponds to a very large anomaly in the conductivity data.

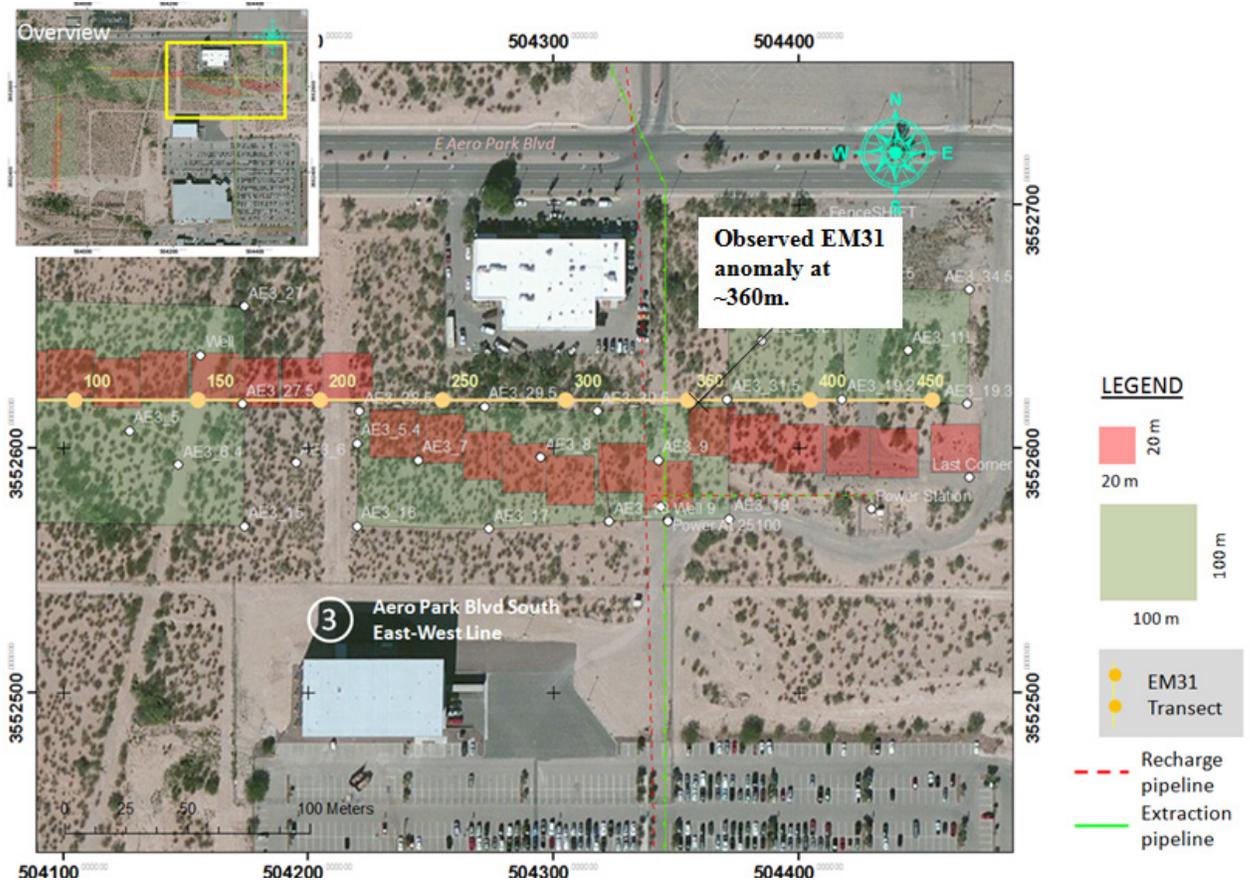
Figure 3.12: Map displaying observed anomaly at approximately 360m along Aero Park Blvd W-E Line. This anomaly correlates well with a set of pipes plotted on the maps.

On the second line; Aero Park Blvd W-E line, one major anomaly was located at approximately 360 meters along the line. This anomaly correlated well with a known set of pipes that is documented in the maps (Figure 3.12) and shown on the graphs (Figures 3.5-3.6). However, a utility access hole cover was found approximately 20 meters south of our line, which read "POWER LINES", though nothing related to power lines is shown in any of the maps near that location. It is possible that the power lines are not shown on the maps we have. The anomaly can be identified as a trough and peak in both the conductivity and in phase plots (Figures 3.5-3.6), followed thereafter by an increase in conductivity towards the end of the data sets from 20-

25 mS/m. The location of the extraction pipe labeled in the maps corresponds with the inflection point seen in the anomaly, making it the probable cause of the anomaly. An abrupt increase in the in phase component is visible at 50 meters along this line. At this point there is a 20-meter offset in the data due to the dense vegetation. The data were also collected on different days, indicating that the offset in the data was likely due to the calibration of the equipment.

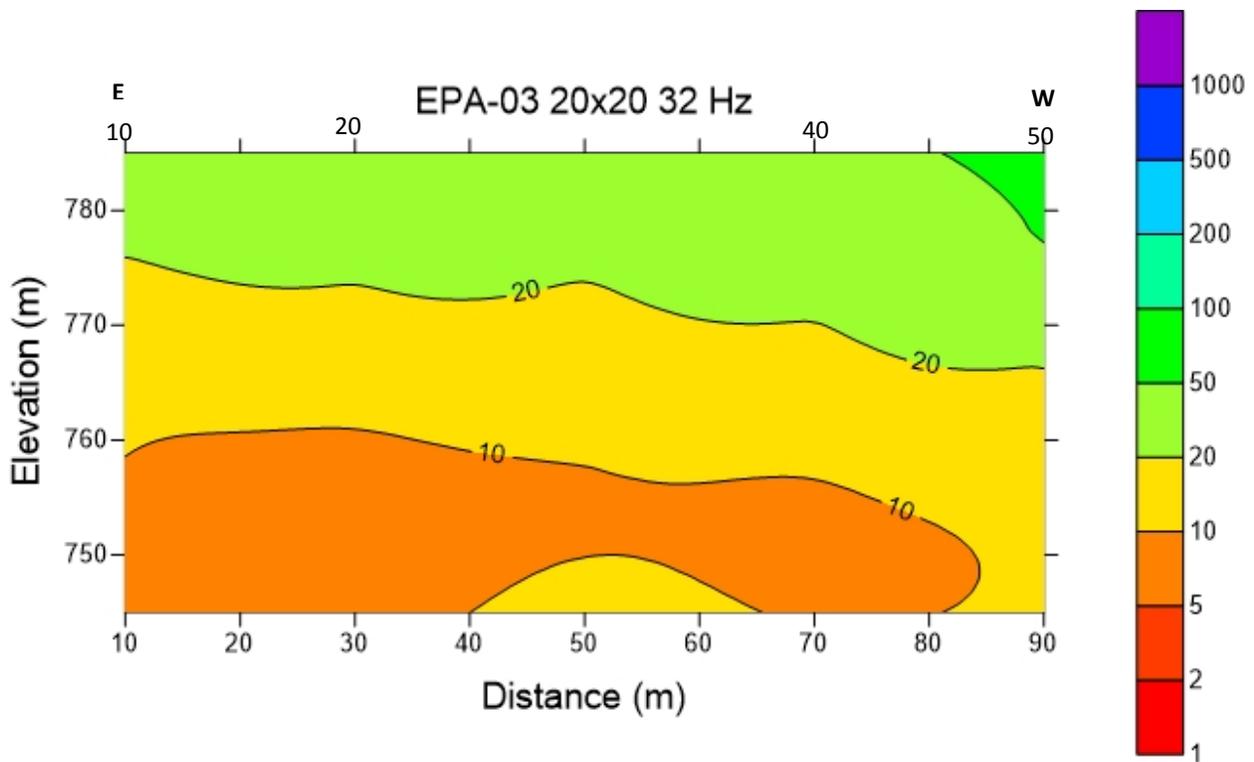
Figure 4.4 EPA-03 site with 20x20 loops running 32 Hz.

2. For EPA-03, the two EMIGMA inversion results (Figure 5.4 and Figure 5.8) and the two STEMINV inversion results (Figure 4.4 and Figure 4.8) all indicate the same resistivity change from the shallow to the deep. There are differences between the 32Hz and 64Hz inversion results. This could be caused by the pre-processing of the raw data, including deletion of some noisy time channels. The anomalies are mainly concentrated in the east area of this profile from 0 to 60m.

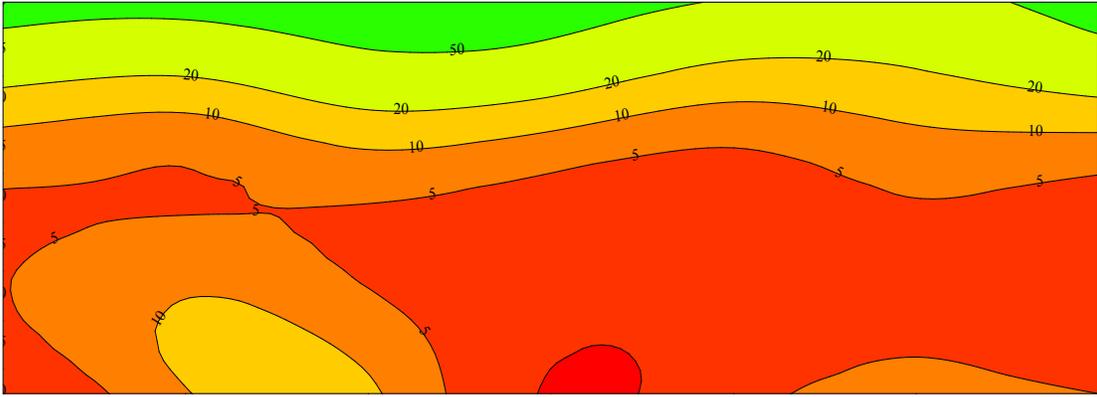
Fig 5.1 Inversion results of Samsonite North, NS line field data

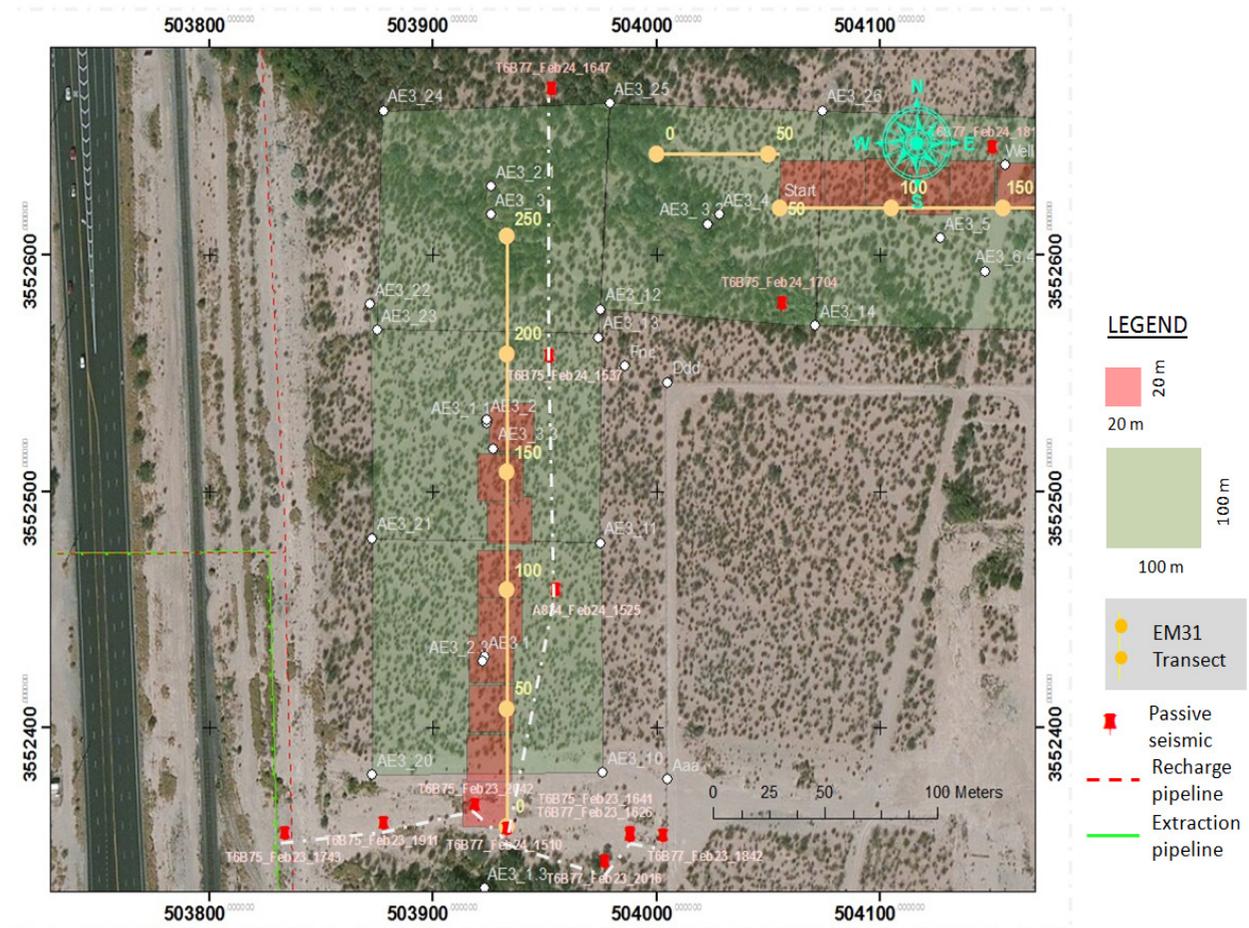
**Figure 6.1:** Map showing locations of seismometers and seismic lines 1 & 2 oriented E-W and N-S respectively in the western part of Aero Park Boulevard South. Seismometers are marked with red pins. Seismic lines are marked with a white dashed line.

The data were collected at the Aero Park Boulevard South and EPA-03 sites (Figures 6.1, 6.2, and 6.3). The measurements are based on single stations with three recorded components: north, east, and vertical. Three seismometers were used in the study, Guralp T6B75, T6B77, and A834, the latter of which was used as the base seismometer. A gravimeter plate was used throughout the survey to act as leveling plate. The duration of data recordings is shown in Table 6.1.

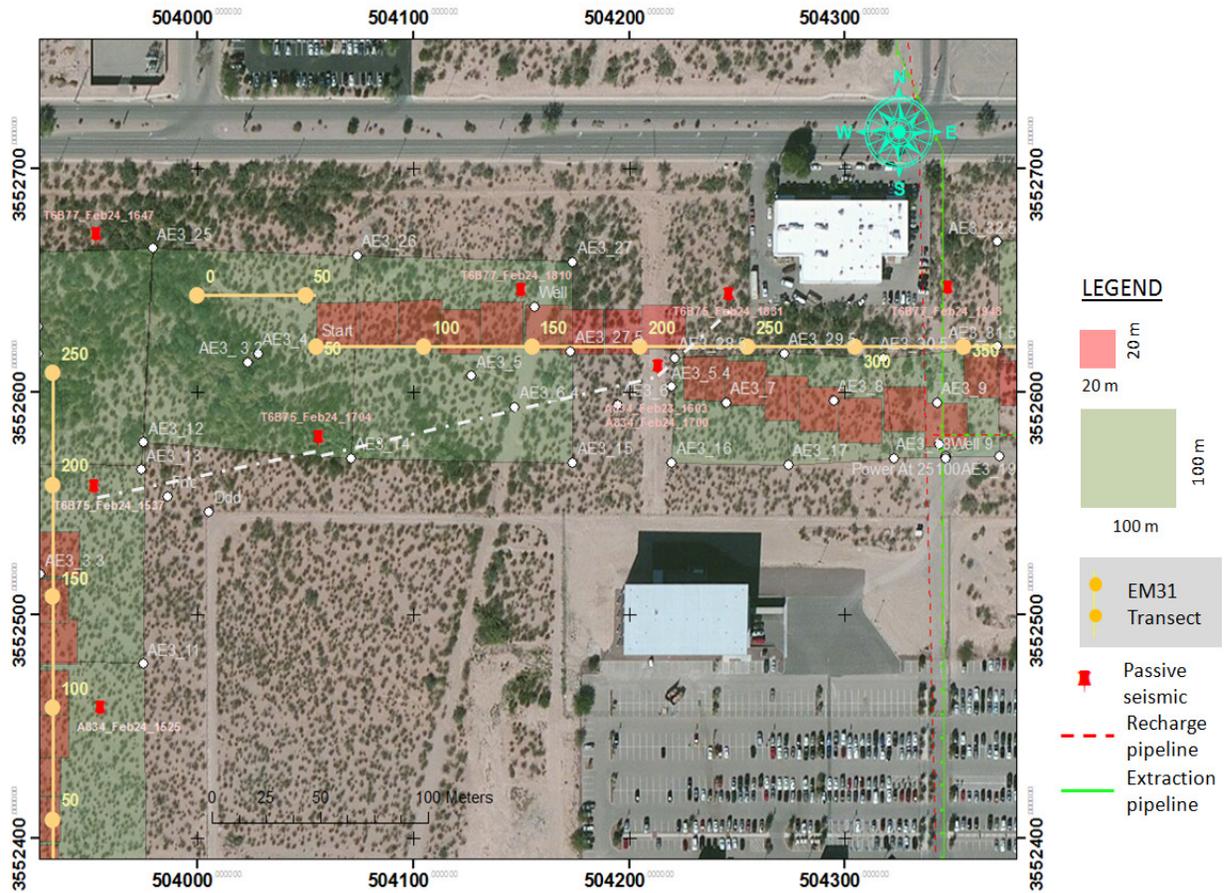
**Figure 6.2:** Map showing locations of seismometers and seismic line 3 oriented E-W in the northern part of Aero Park Boulevard South. Seismometers are marked with red pins. Seismic line is marked with a white dashed line.

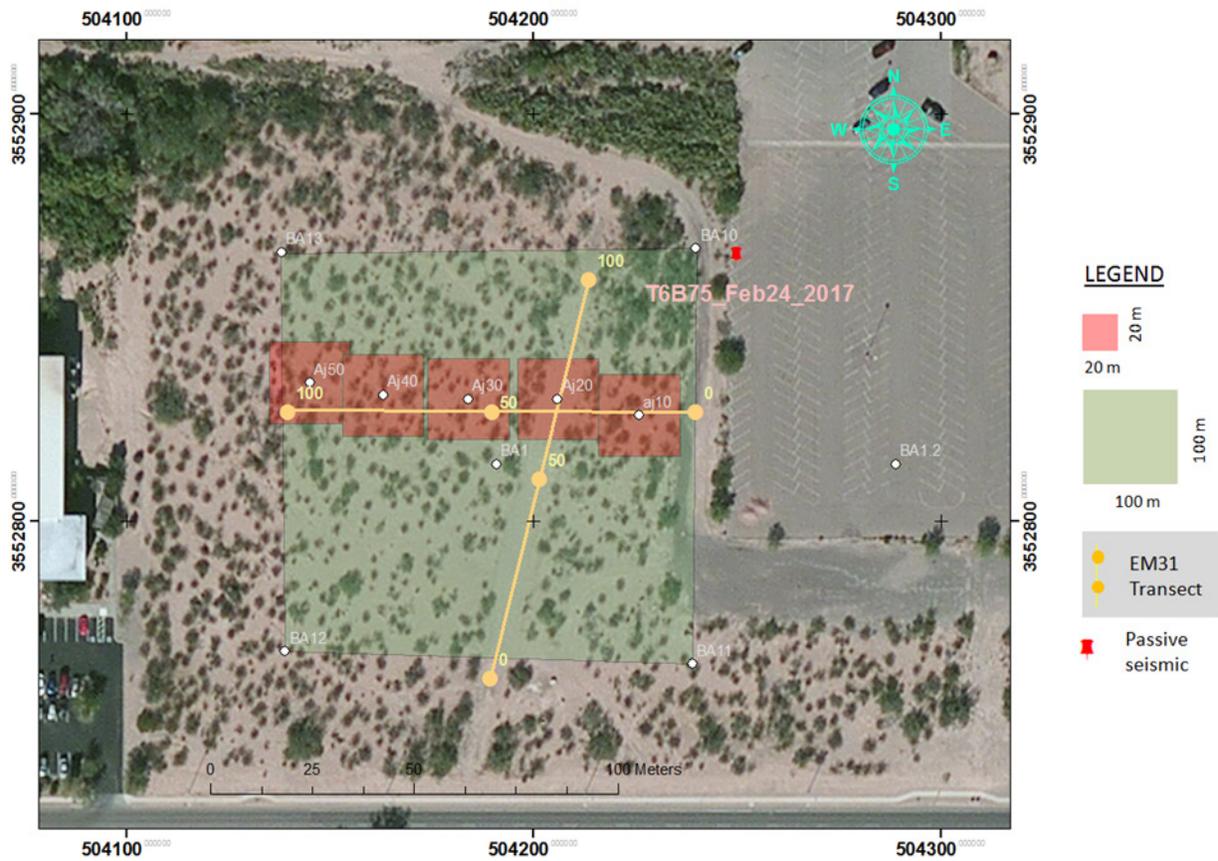
**Figure 6.3:** Map showing location of seismometer in EPA-03 site. Seismometer is marked with red pin.

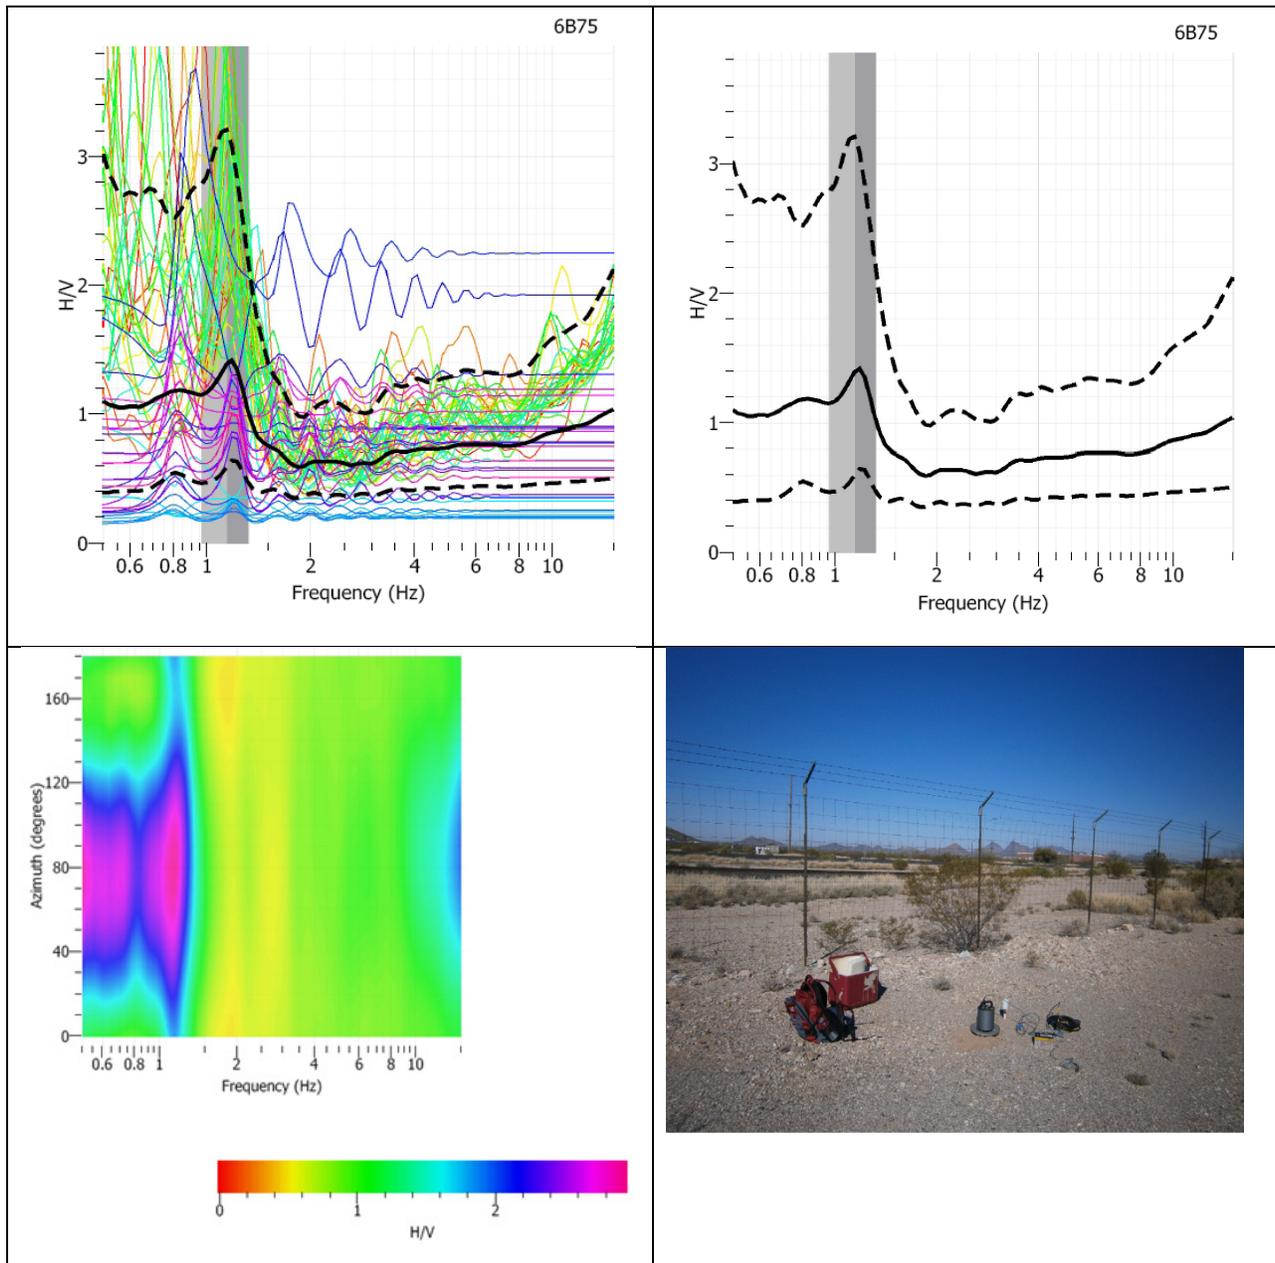
**Figure 6.4:** Measurement T6B75\_Feb23\_1641 (and T6B75\_Feb23\_1743) with (a) individual H/V window peaks, (b) mean H/V peak of 1.119 Hz (corresponding depth: 249.06 m), and (c) H/V rotate analysis, indicating a seismic source that seems to arrive in the directions between 40 and 120 degrees, and (d) a photograph showing the seismometer measurement taken approximately 70 meters from a busy road.
