**Geophysical Surveys Near  
Tucson International Airport**

**Geophysics Field Camp 2013  
LASI-13-1  
May 15, 2013**

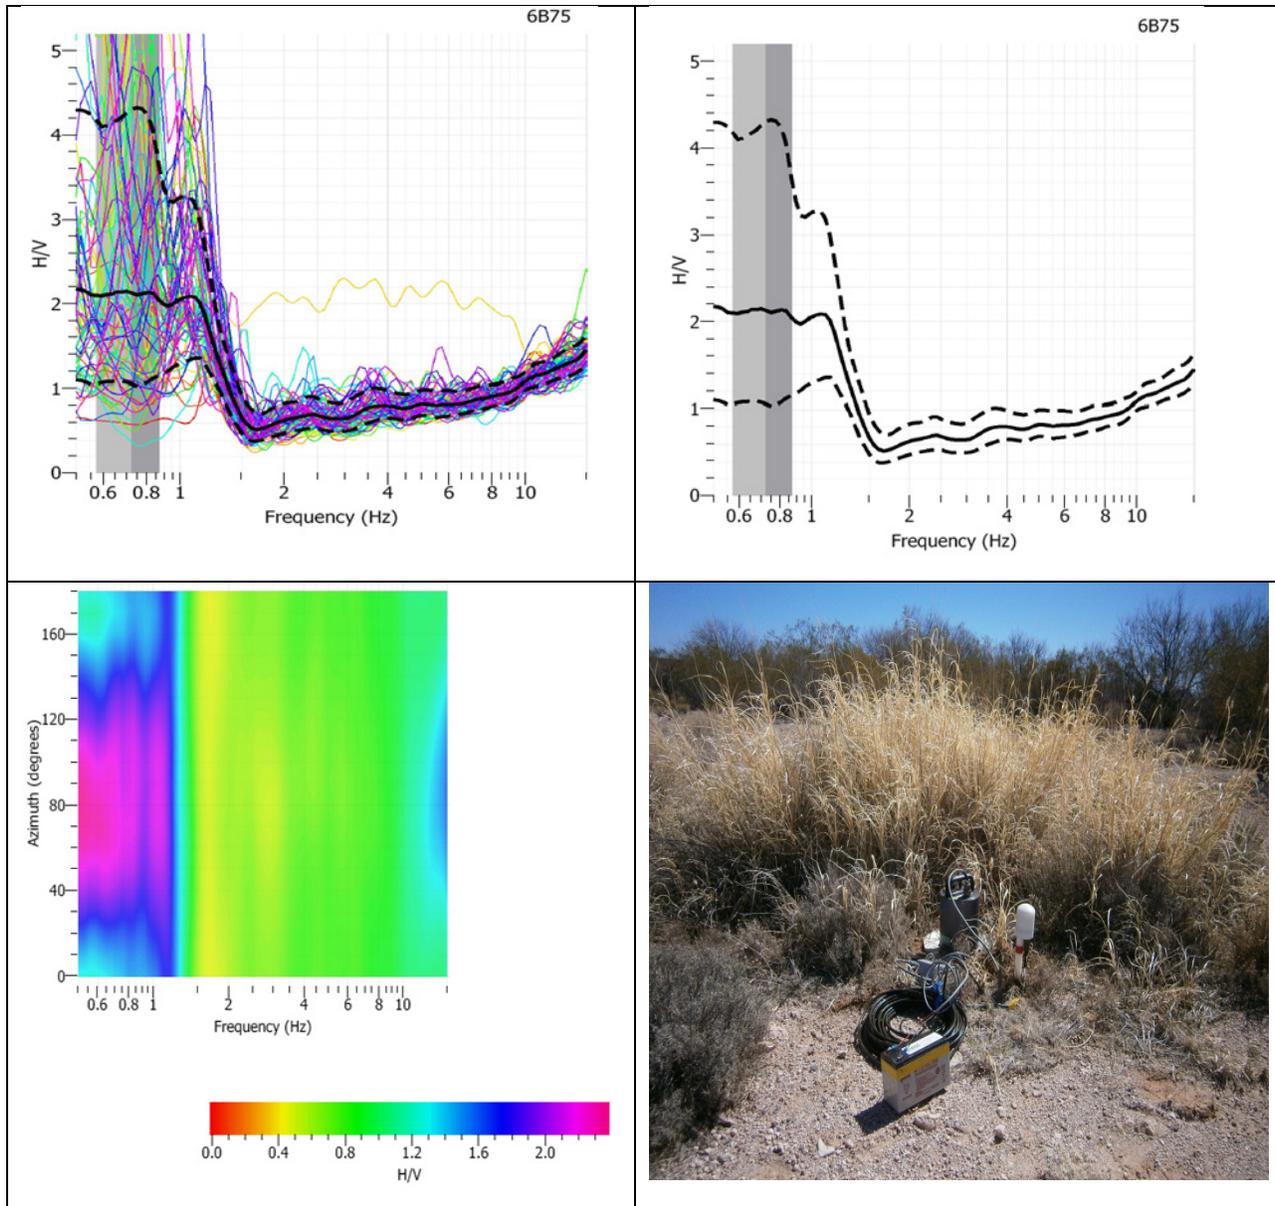
**Figure 6.6:** Seismometer measurement T6B75\_Feb23\_1911 with (a) individual H/V window peaks, (b) mean H/V peak of 0.726 Hz (corresponding depth: 383.88 m), and (c) H/V rotate analysis, indicating a seismic source that seems to arrive in the directions between 40 and 120 degrees, and (d) a photograph showing the seismometer measurement taken close to low vegetation.

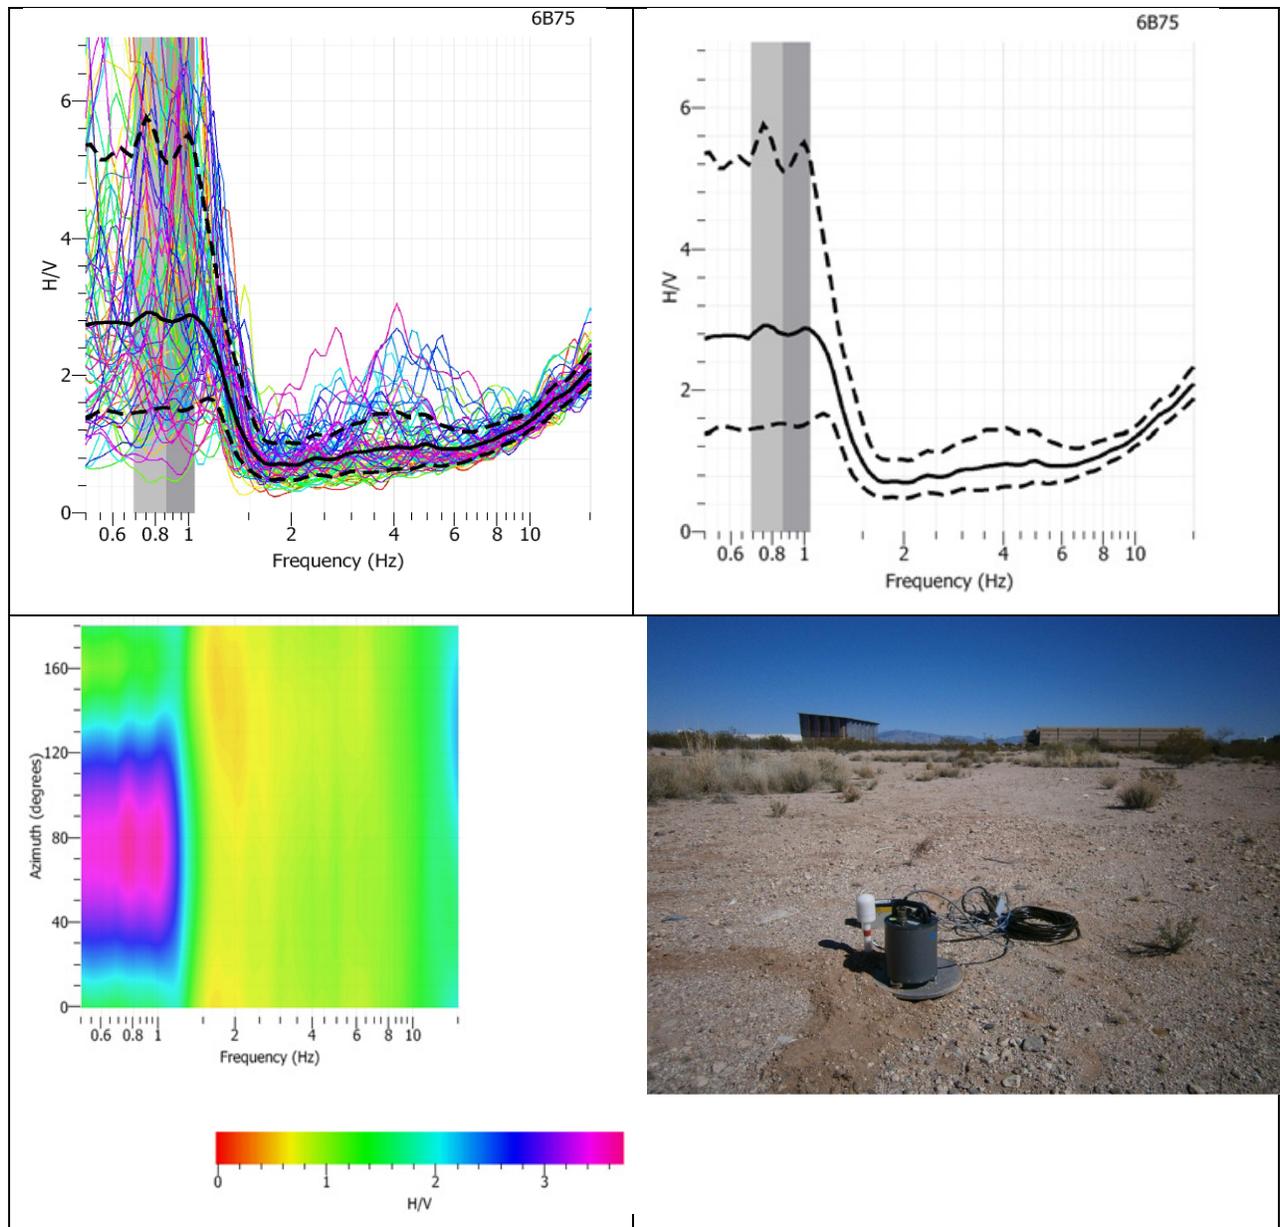
**Figure 6.7:** Seismometer measurement T6B75\_Feb23\_2042 with (a) individual H/V window peaks, (b) mean H/V peak of 0.867 Hz (corresponding depth: 321.45 m), and (c) H/V rotate analysis, indicating a seismic source that seems to arrive in the directions between 40 and 120 degrees, and (d) a photograph showing the seismometer measurement taken halfway between nearby buildings and busy road.

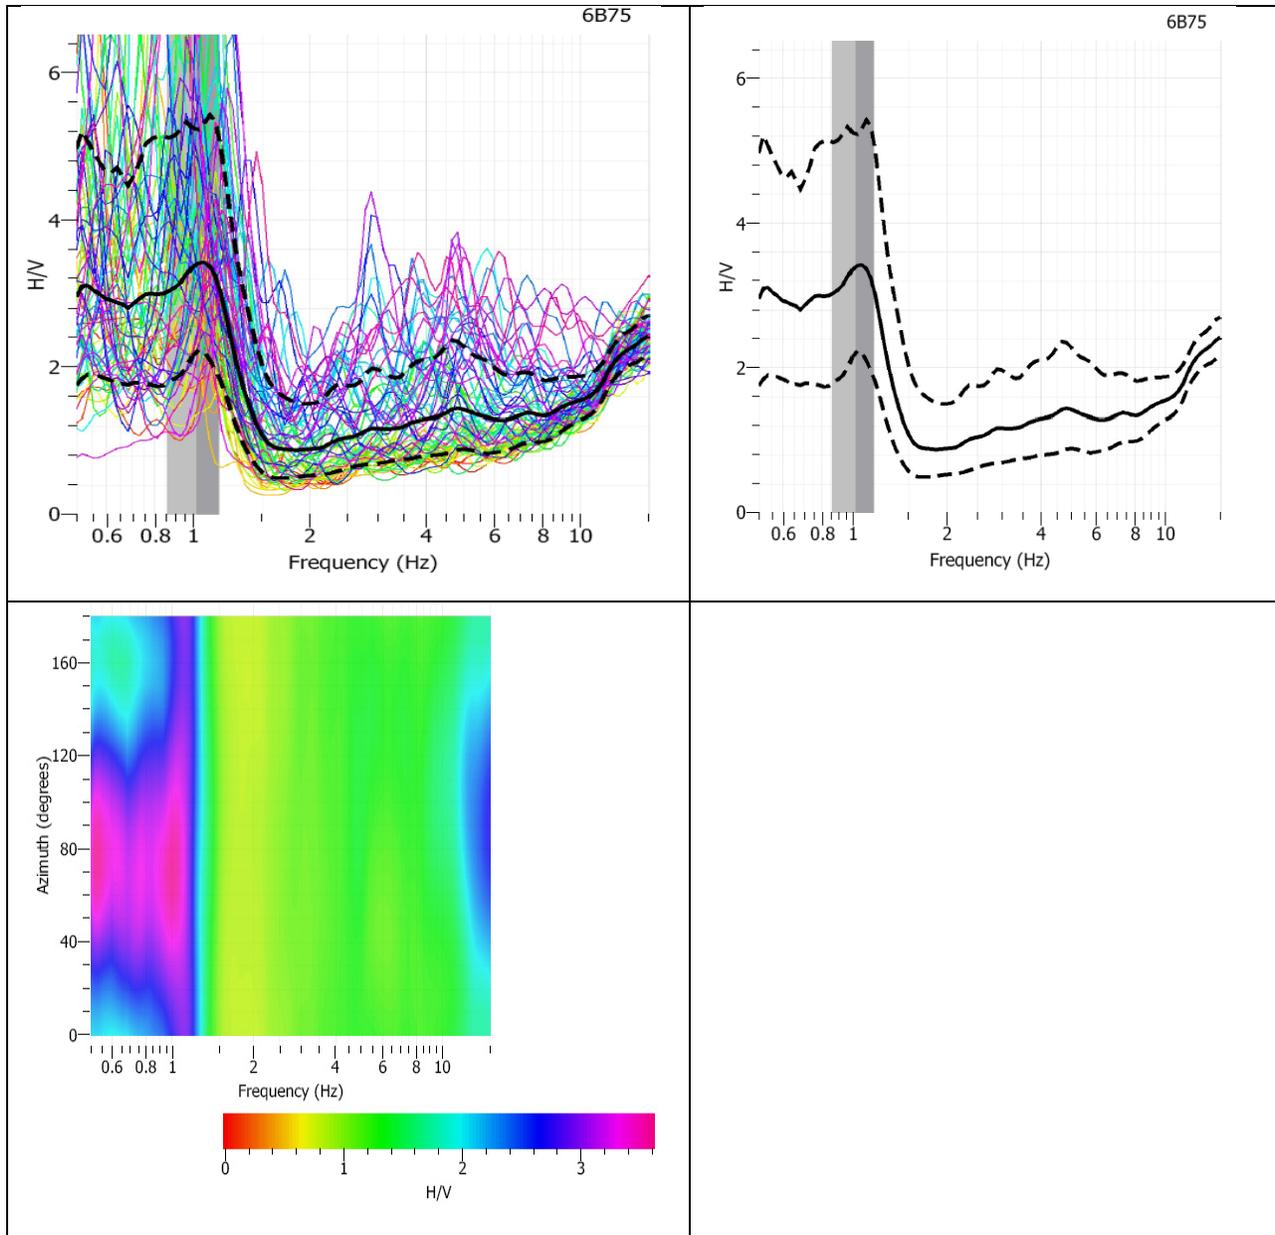
**Figure 6.8:** Seismometer measurement T6B75\_Feb24\_1537 with (a) individual H/V window peaks, (b) mean H/V peak of 1.013 Hz (corresponding depth: 275.1 m), and (c) H/V rotate analysis, indicating a seismic source that seems to arrive from all directions.

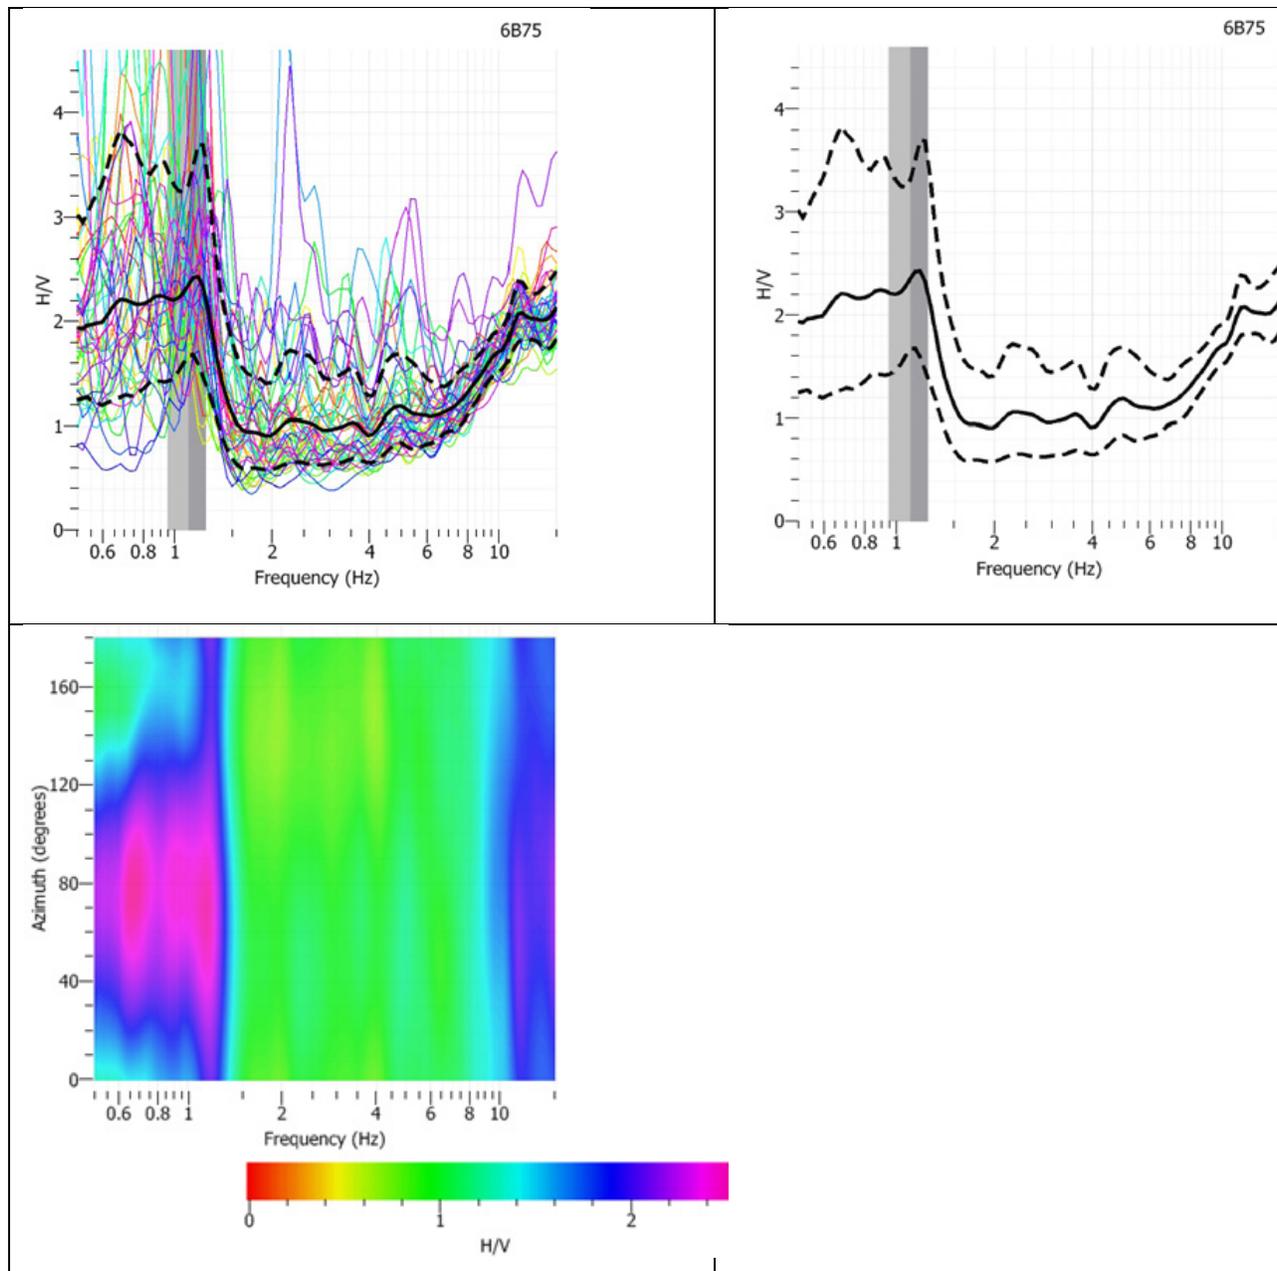
**Figure 6.9:** Seismometer measurement T6B75\_Feb24\_1704 with (a) individual H/V window peaks, (b) mean H/V peak of 1.099 Hz (corresponding depth: 253.59 m), and (c) H/V rotate analysis, indicating a seismic source that seems to arrive from 40 – 120 degrees.

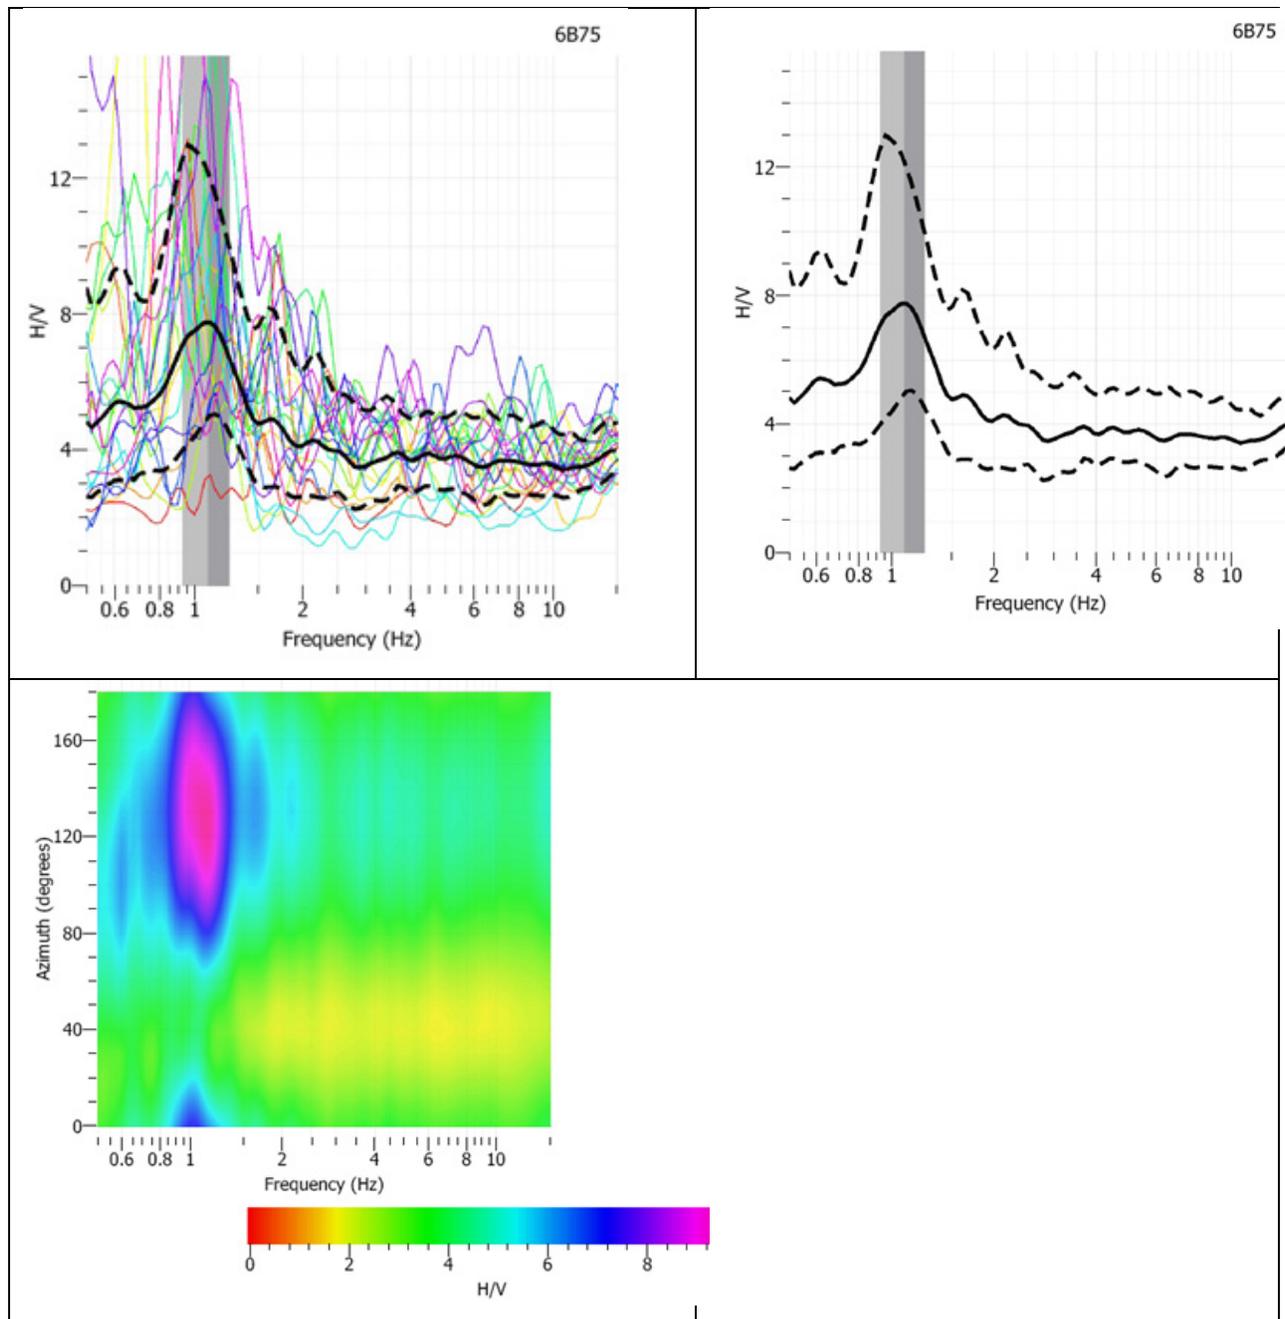
**Figure 6.10:** Seismometer measurement T6B75\_Feb24\_1831 with (a) individual H/V window peaks, (b) mean H/V peak of 1.089 Hz (corresponding depth: 255.92 m), and (c) H/V rotate analysis, indicating a seismic source that seems to be concentrated in one direction along azimuths between 80 and 180 degrees.

T6B75\_Feb24\_1831 (Figure 6.10) had a source concentrated in one direction, and there was some slight noise. One H/V peak was detected at 1.089 Hz, giving a corresponding depth of 256 meters. Lastly, measurement T6B75\_Feb24\_2017 (Figure 6.11) had a source that was concentrated in one direction and experienced some slight noise. An H/V peak was present at 0.706 Hz with a corresponding depth at 395 meters. The majority of the H/V spectral peaks were detected around 1 Hz, indicating that only one boundary had a large enough acoustic impedance to be detected.

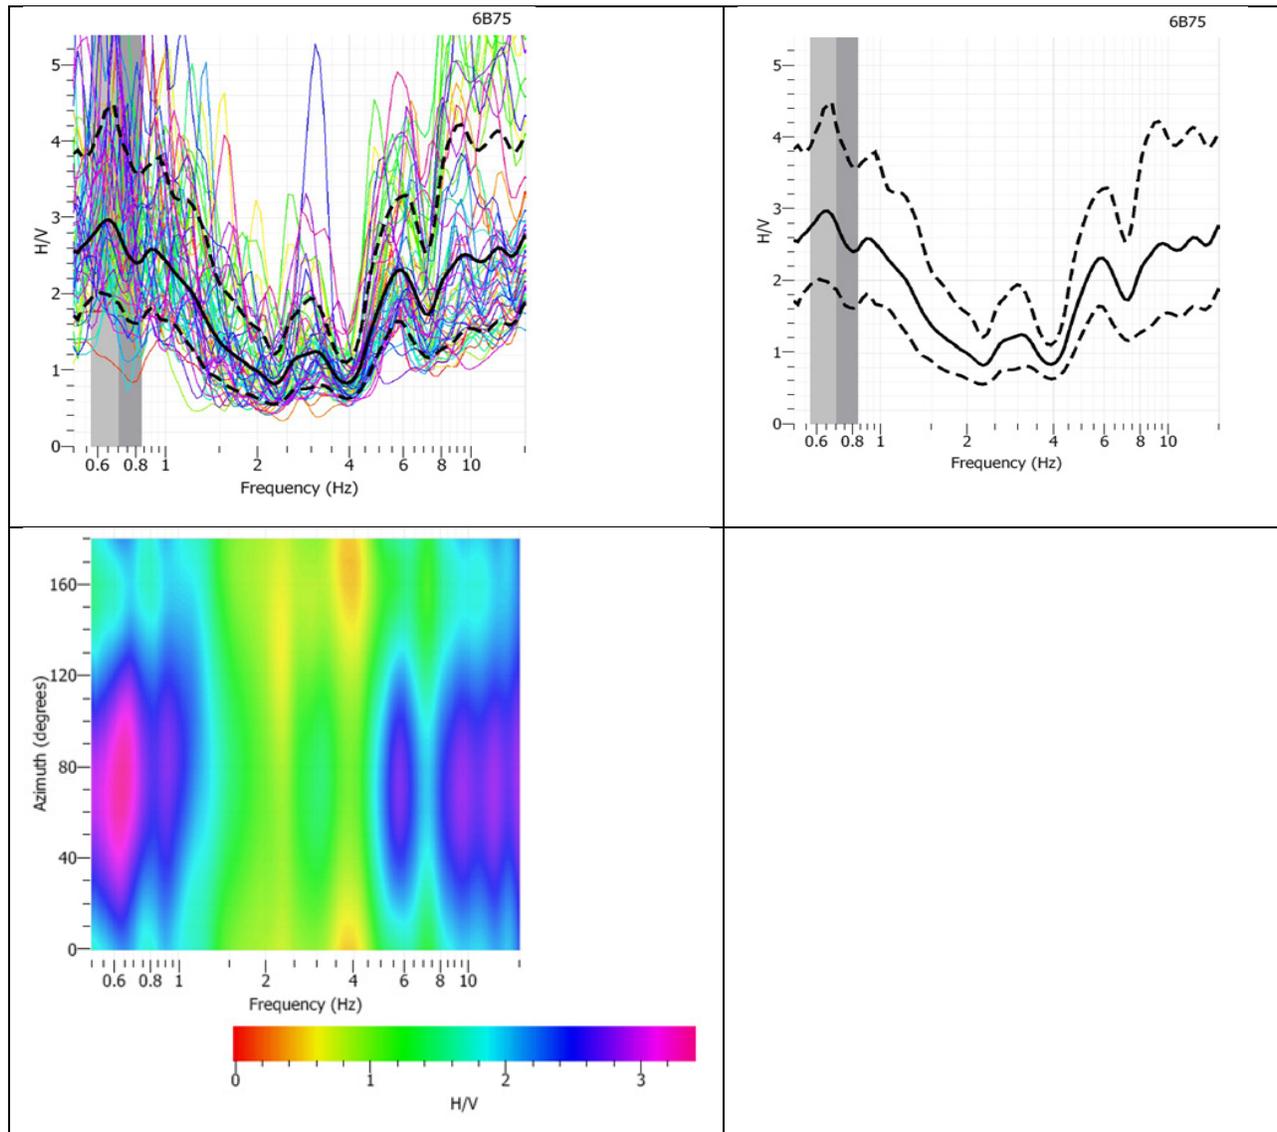
**Figure 6.11:** Seismometer measurement T6B75\_Feb24\_2017 with (a) individual H/V window peaks, (b) mean H/V peak of 0.706 Hz (corresponding depth: 394.76 m), and (c) H/V rotate analysis, indicating a seismic source that seems to be concentrated in one direction, at EPA-03.

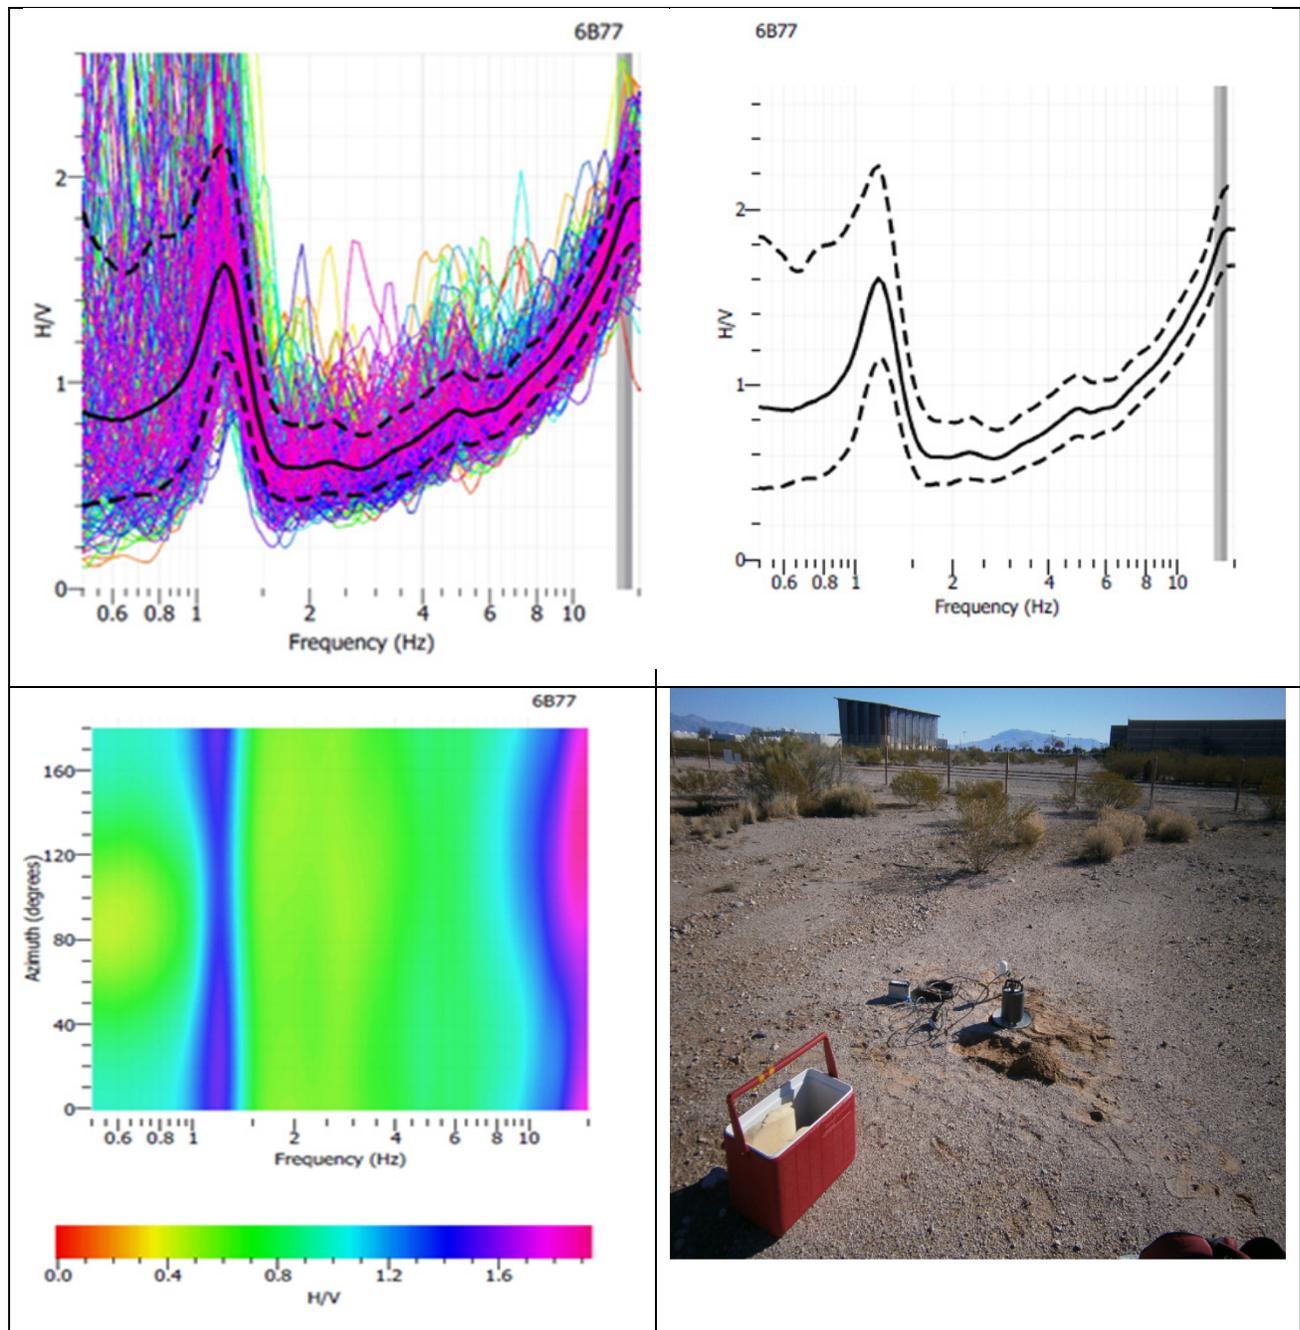
**Figure 6.12:** Seismometer measurement T6B77\_Feb23\_1626 with (a) individual H/V window peaks, (b) mean H/V peak 1 of 1.25 Hz (corresponding depth: 223 m), and mean peak 2 of 13.65 Hz (corresponding depth: 20.4 m) and (c) H/V rotate analysis, indicating a seismic source that seems to arrive in all directions, and (d) a photograph showing the seismometer measurement taken in an open area with no nearby vegetation.

This section focuses on the H/V and H/V rotate analyses for seismometer measurements for the Guralp T6B77 presented in Figures 6.12 through 6.18. Seismometer measurement T6B77\_Feb23\_1626, which was taken in an open area with no nearby vegetation (Figure 6.12) has a mean H/V peak 1 of 1.25 Hz, with a corresponding depth of 223 m, and a mean peak 2 of 13.65 Hz, which corresponds to a depth of 20.4 m. Its H/V rotate analysis, indicating a seismic source that seems to arrive in all directions. Seismometer measurement T6B77\_Feb23\_1842 was taken near an electrified fence (Figure 6.13). It has a mean H/V peak 1 of 1.084 Hz, with a corresponding depth of 257 m, and a mean peak 2 of 14.15 Hz, which corresponds to a depth of 19.7m. Its H/V rotate analysis indicates a seismic source that seems to arrive from all directions. Seismometer measurement T6B77\_Feb23\_2016, taken near a tall tree with roots beneath the seismometer (Figure 6.14) has a mean H/V peak of 1.021 Hz that corresponds to a depth of 273 m. Its H/V rotate analysis suggests a seismic source that seems to arrive from all directions. Seismometer measurement T6BD77\_Feb24\_1510 (Figure 6.15) has a mean H/V peak 1.024 Hz, and corresponding depth of 272 m. Its H/V rotate analysis implies a seismic source that seems to arrive from all directions. Seismometer measurement T6B77\_Feb24\_1647 (Figure 6.16) has a mean H/V peak of 1.186 Hz and has a corresponding depth of 235 m. Its H/V rotate analysis indicates seismic sources that concentrate from north and south. Seismometer measurement T6B77\_Feb24\_1810 (Figure 6.17) has a mean peak at 1.092 Hz and has a corresponding depth of 255m. Its H/V rotate analysis indicates seismic sources from all direction. Seismometer measurement T6B77\_Feb24\_1948 (Figure 6.18) with (a) has a mean H/V peak at 1.192 Hz, with corresponding depth of 234 m. Its H/V rotate analysis suggests seismic sources that arrive from all directions.

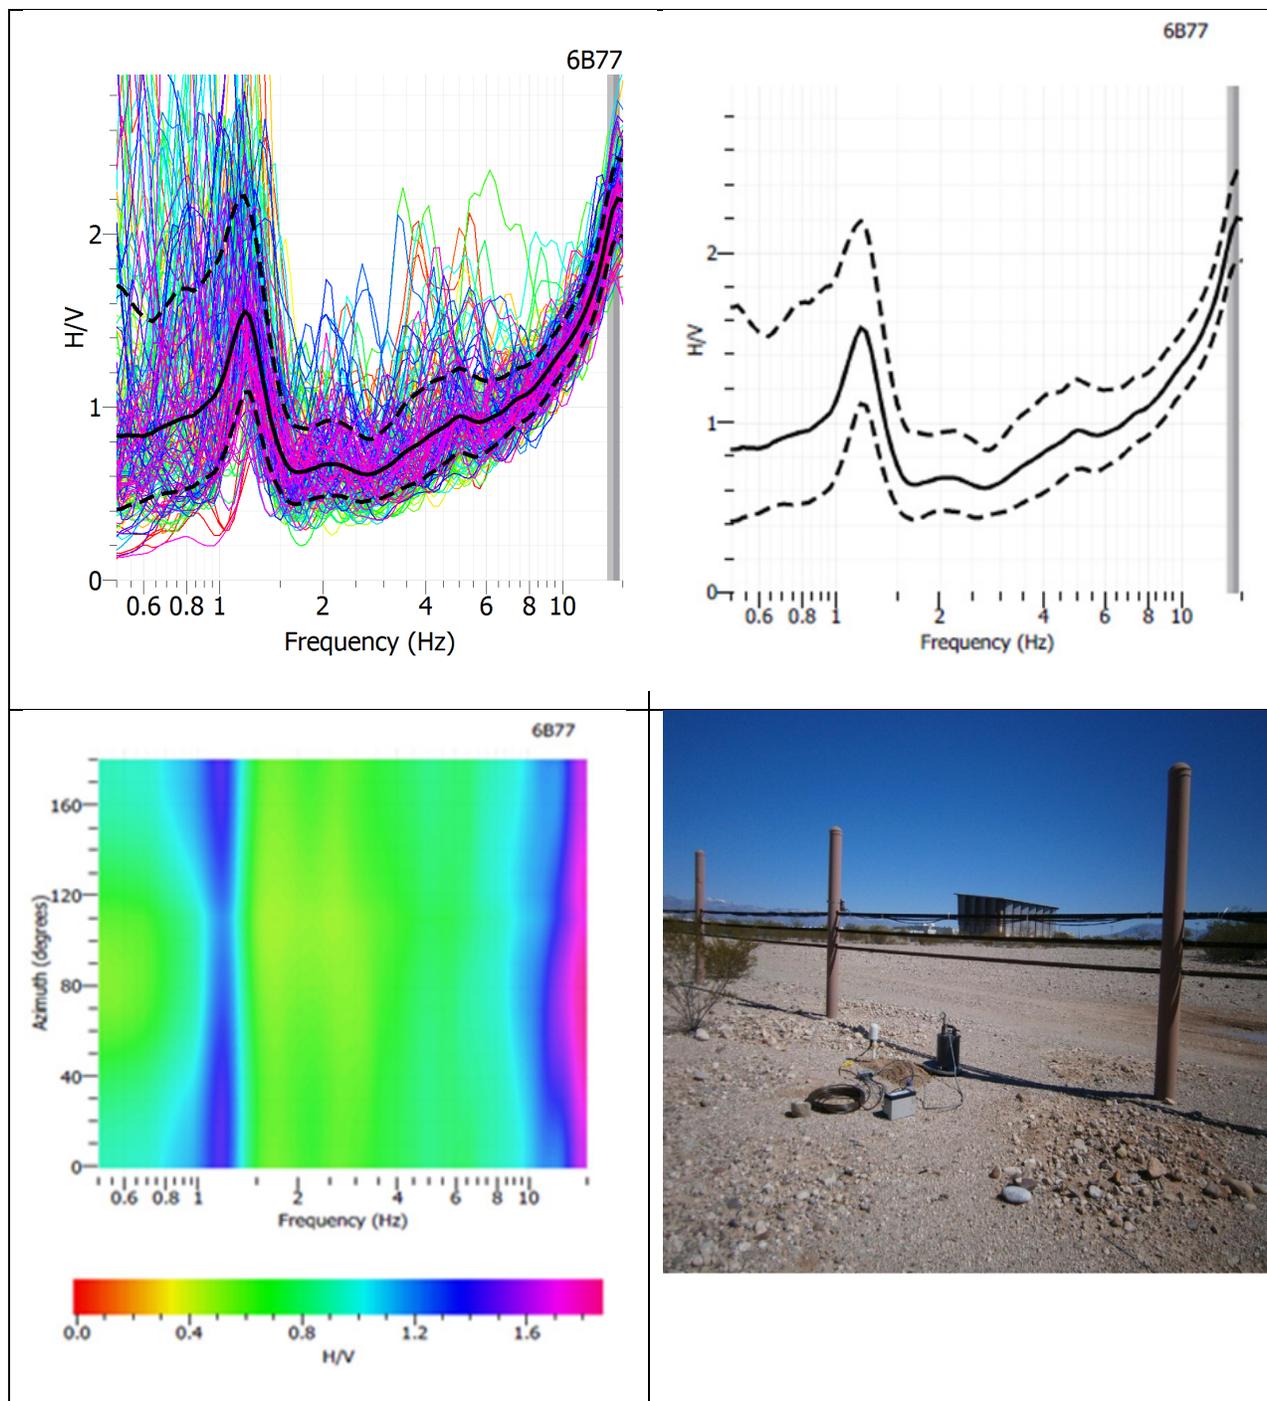
**Figure 6.13:** Seismometer measurement T6B77\_Feb23\_1842 with (a) individual H/V window peaks, (b) mean H/V peak 1 of 1.084 Hz (corresponding depth: 257.1 m), and mean peak 2 of 14.15 Hz (corresponding depth: 19.69m) and (c) H/V rotate analysis, indicating a seismic source that seems to arrive from all directions, and (d) a photograph showing the seismometer measurement taken close to an electrified fence.

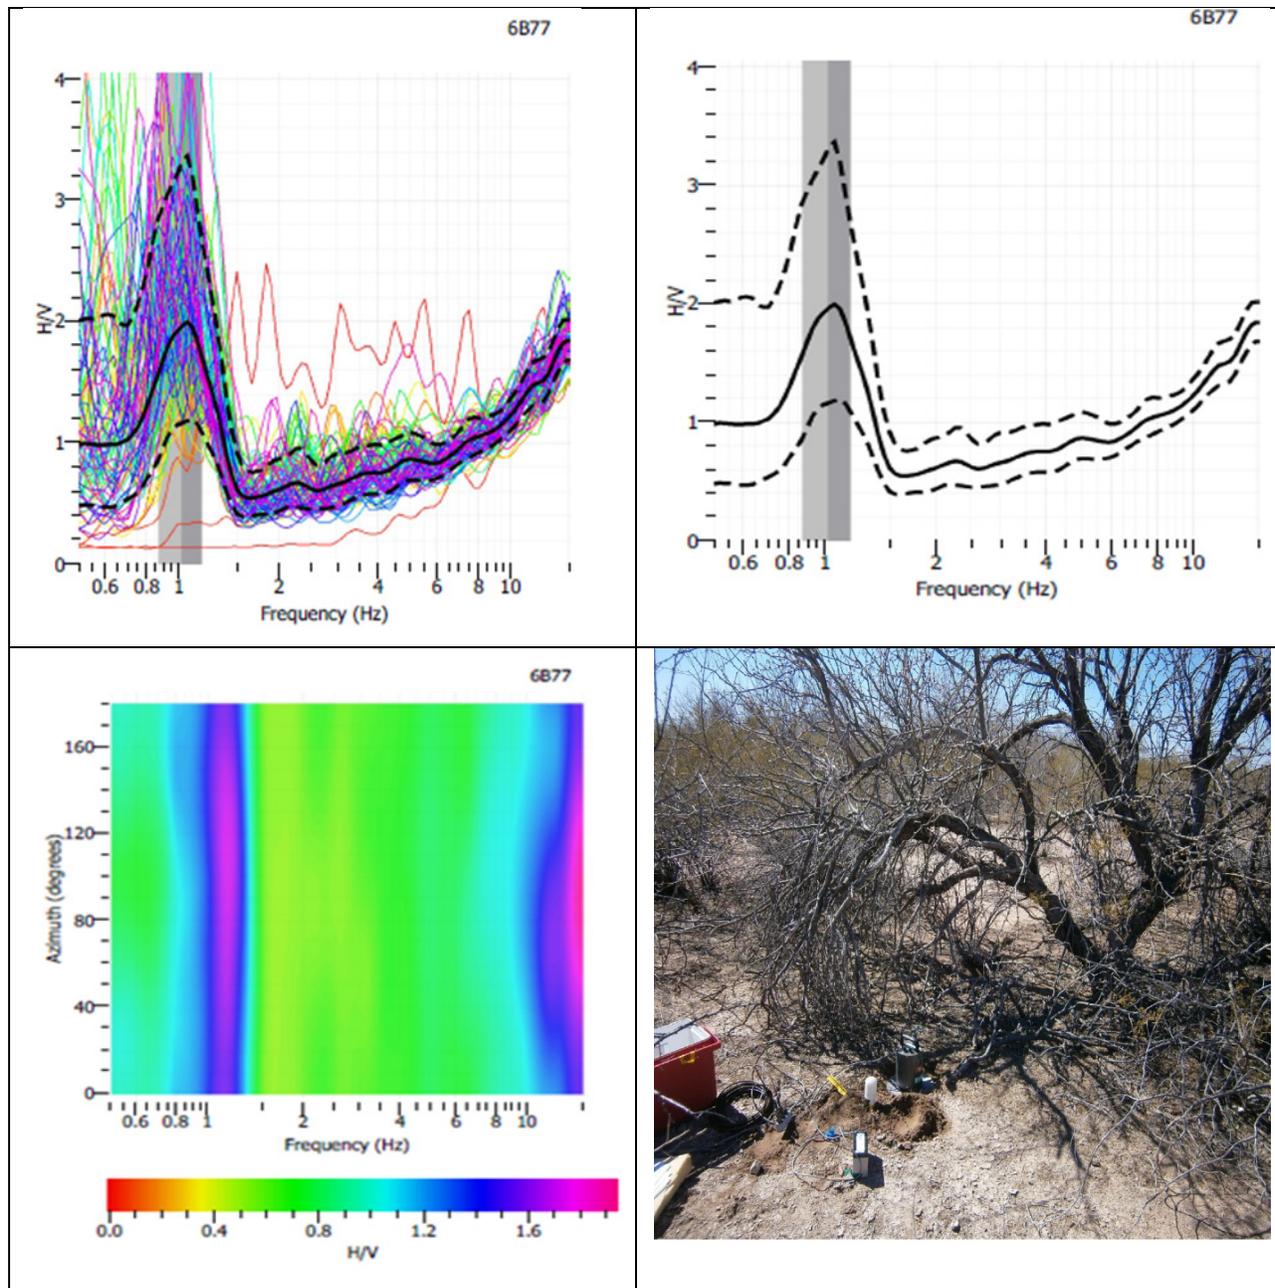
**Figure 6.14:** Seismometer measurement T6B77\_Feb23\_2016 with (a) individual H/V window peaks, (b) mean H/V peak of 1.021 Hz (corresponding depth: 273 m) and (c) H/V rotate analysis, indicating a seismic source that seems to arrive from all directions, and (d) a photograph showing the seismometer measurement taken by a tall tree with roots beneath the seismometer.

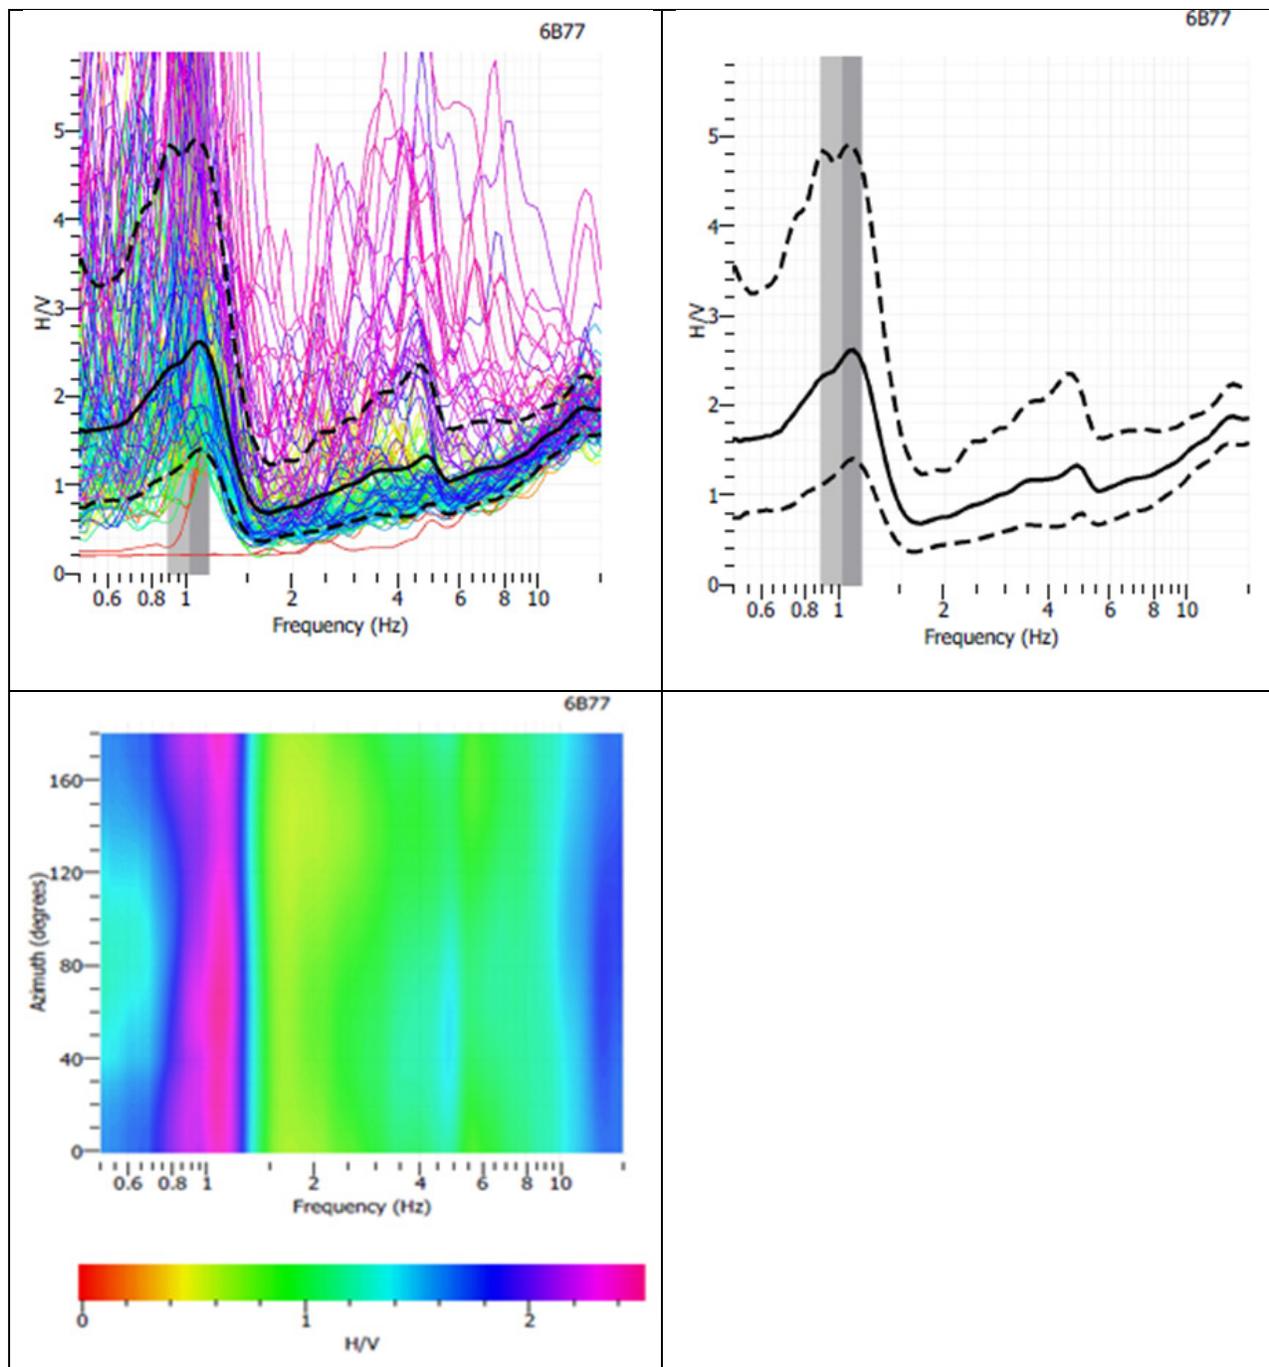
**Figure 6.15:** Seismometer measurement T6BD77\_Feb24\_1510 with (a) individual H/V window peaks, (b) mean H/V peak 1.024 Hz (corresponding depth: 272.1 m) and (c) H/V rotate analysis, indicating a seismic source that seems to arrive from all directions.

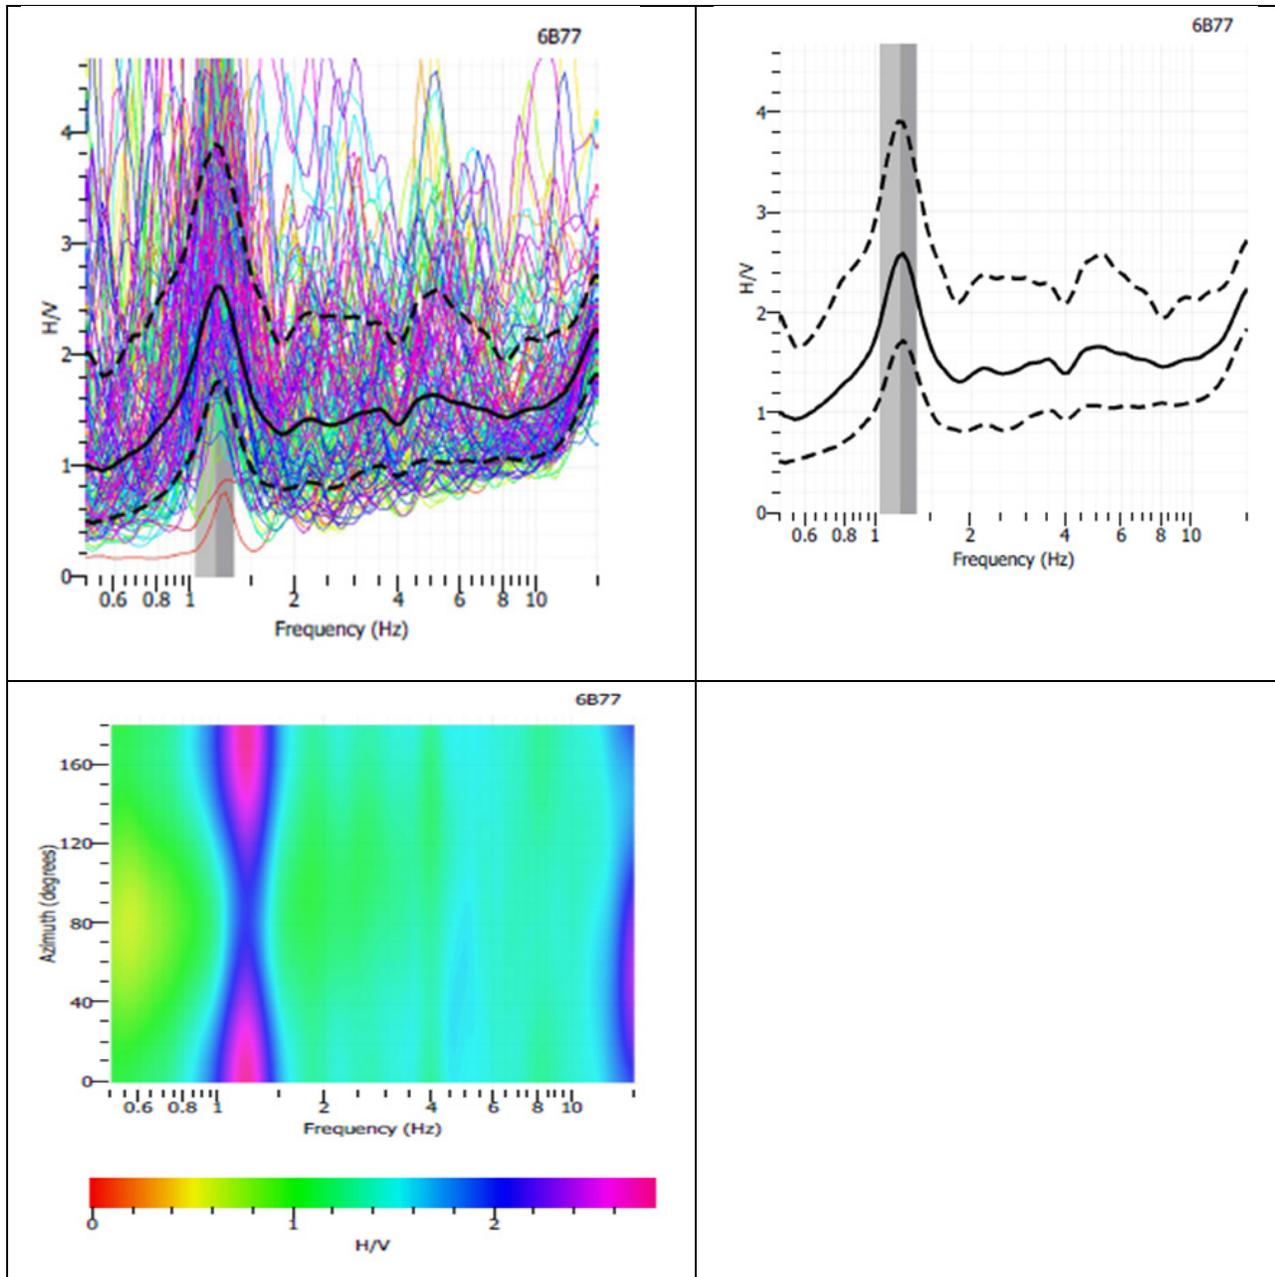
**Figure 6.16:** Seismometer measurement T6B77\_Feb24\_1647 with (a) individual H/V window peaks, (b) mean H/V peak 1.186 Hz (corresponding depth: 235.1 m) and (c) H/V rotate analysis, indicating seismic sources that concentrate from north and south.

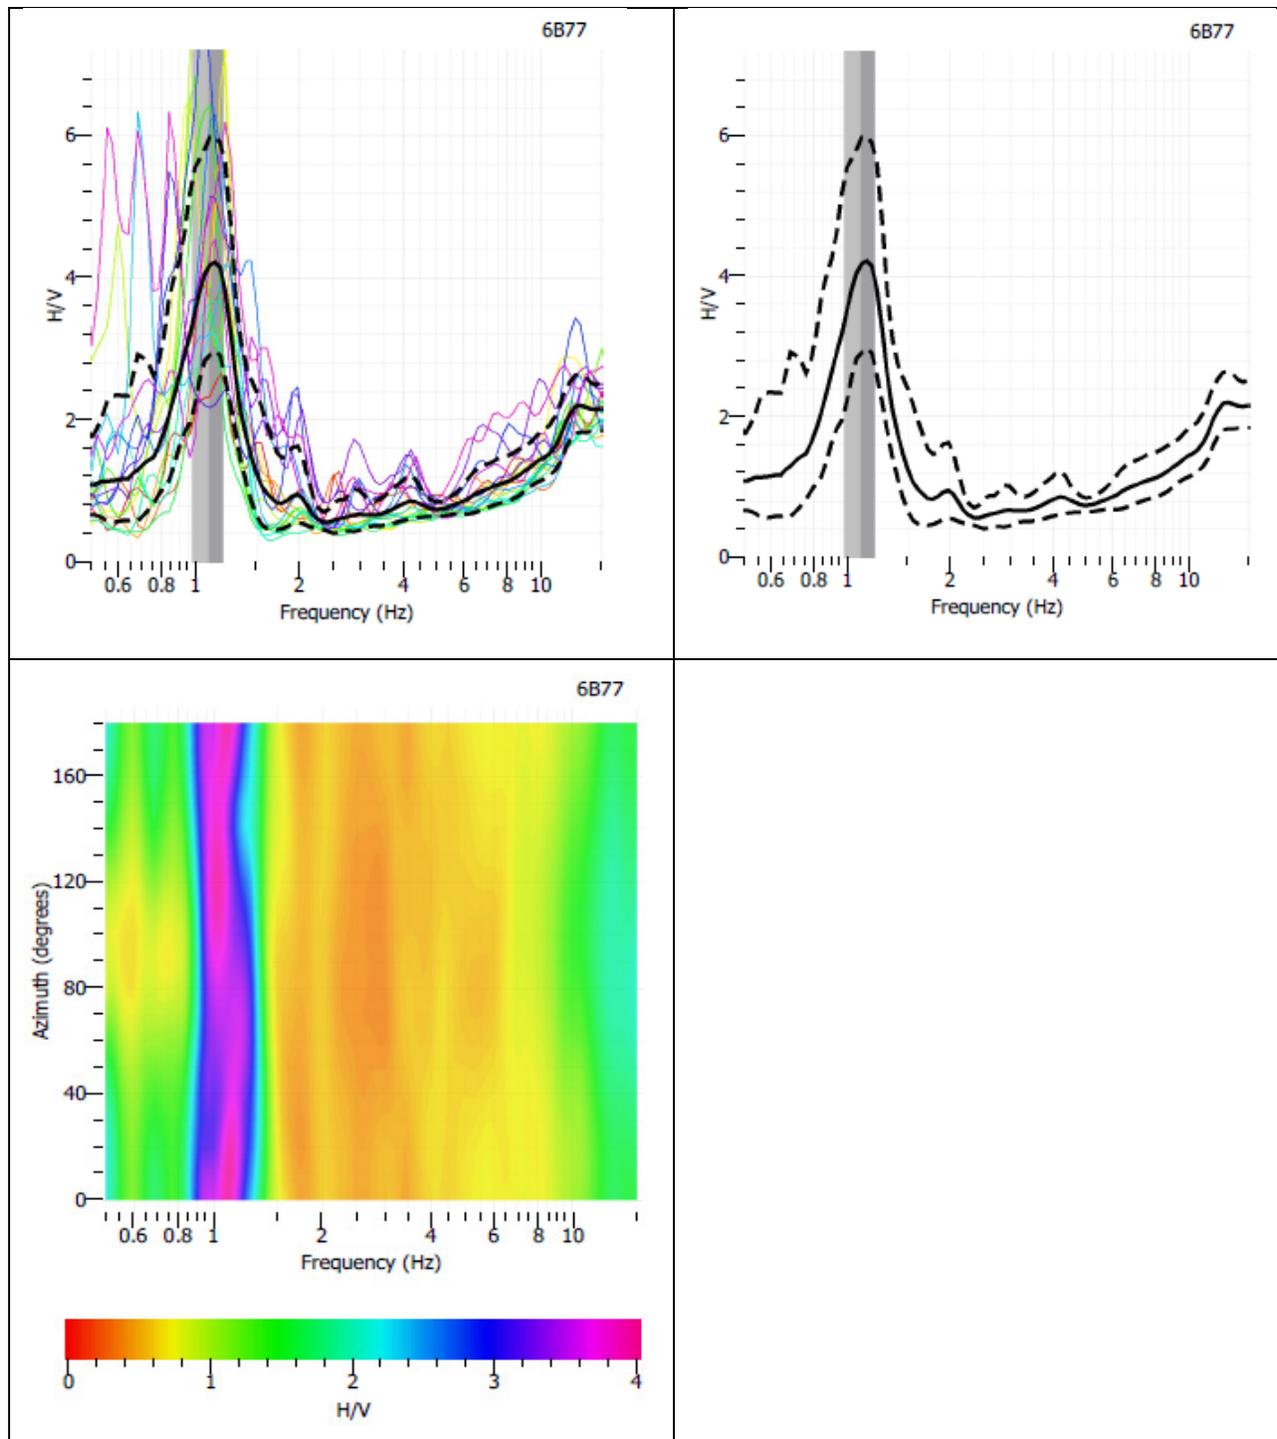
**Figure 6.17:** Seismometer measurement T6B77\_Feb24\_1810 with (a) individual H/V window peaks, (b) mean H/V peak at 1.092Hz (corresponding depth: 235.06m) (c)H/V rotate analysis, indicating source from all direction.
