**Geophysical Surveys Near  
Tucson International Airport**

**Geophysics Field Camp 2013  
LASI-13-1  
May 15, 2013**

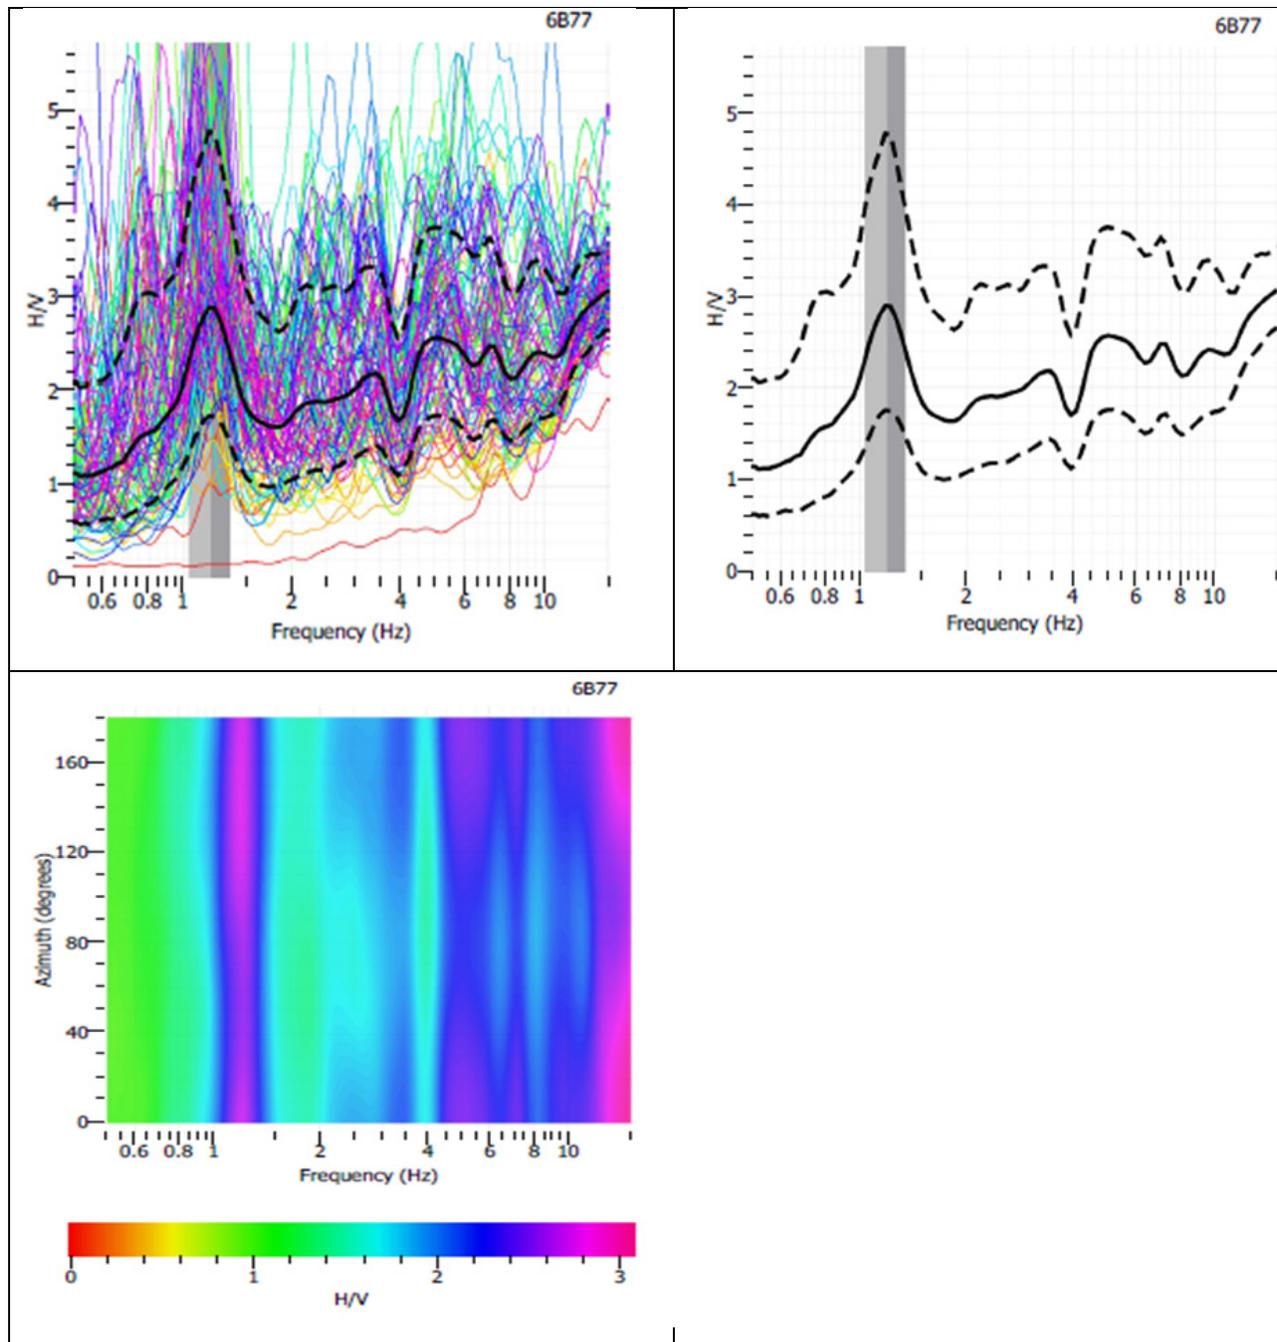
**Figure 6.18:** Seismometer measurement T6B77\_Feb24\_1948 with (a) individual H/V window peaks, (b) mean H/V peak at 1.192 Hz (corresponding depth: 233.8 m) and (c) H/V rotate analysis, indicating seismic sources that arrive from all directions.

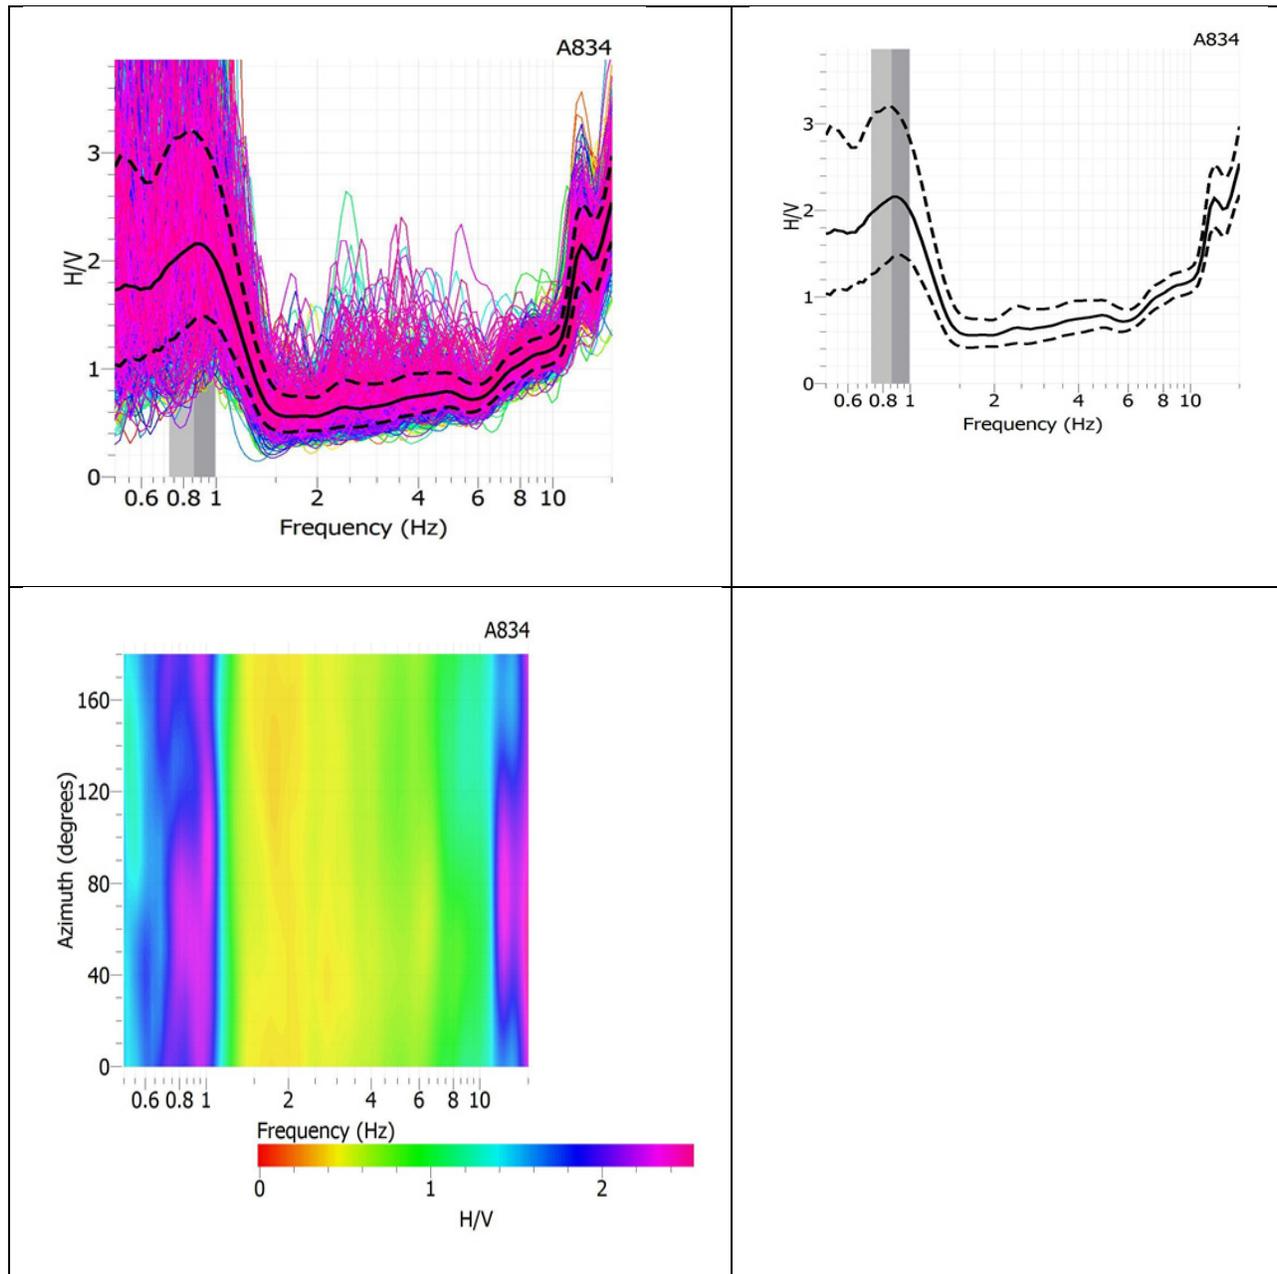
**Figure 6.19:** Seismometer measurement A834\_Feb23\_1603 with (a) individual H/V window peaks, (b) mean H/V peak at 0.864 Hz (corresponding depth: 322.5 m) and (c) H/V rotate analysis, indicating seismic sources that arrive from all directions.

This section focuses on the H/V and H/V rotate analyses for seismometer A834 presented in Figure 6.19 through Figure 6.21. Seismometer A834\_Feb23\_1603 (Figure 6.19) with a mean H/V peak at 0.864 Hz, with a corresponding depth of 323 m. Its H/V rotate analysis implies seismic sources that arrive from all directions. Seismometer measurement A834\_Feb24\_1520 (Figure 6.20) has a mean H/V peak at 0.729 Hz, with a corresponding depth at 382 m. Its H/V rotate analysis indicates seismic sources that arrive from the north and south. Seismometer measurement A834\_Feb24\_1700 (Figure 6.21) has a mean H/V peak at 0.950 Hz, with a corresponding depth at 293 m. Its H/V rotate analysis indicates that seismic sources that arrive from all directions. In this case only one boundary was detected as well.

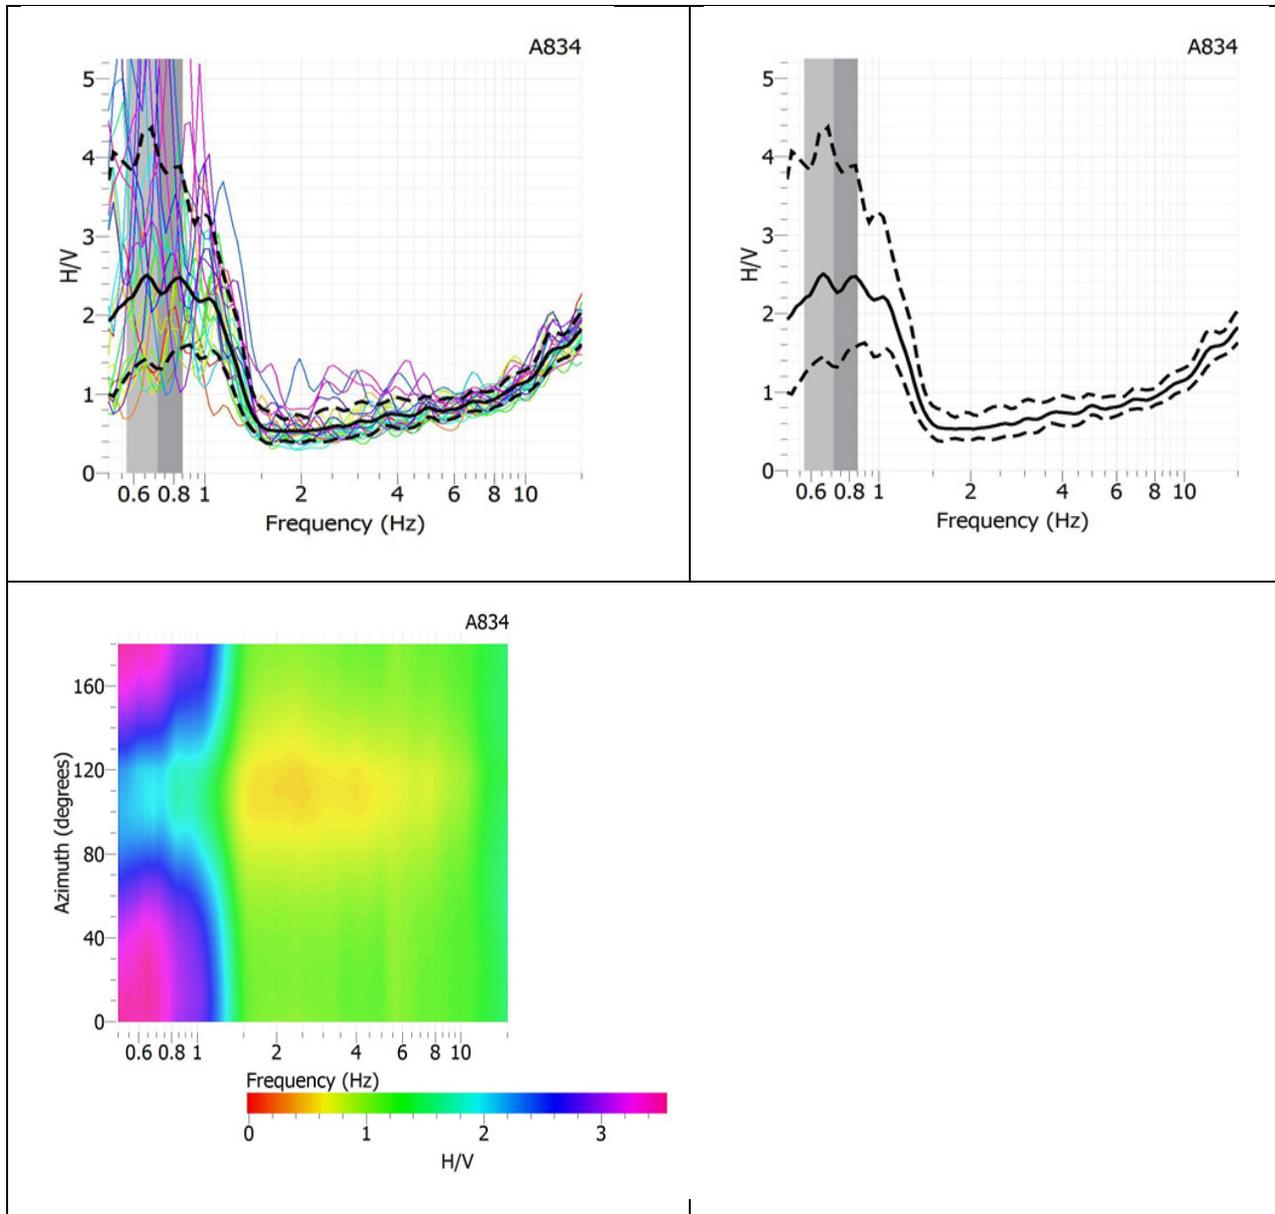
**Figure 6.20:** Seismometer measurement A834\_Feb24\_1525 with (a) individual H/V window peaks, (b) mean H/V peak at 0.729 Hz (corresponding depth: 382.4 m) and (c) H/V rotate analysis, indicating seismic sources that arrive from the north and south.

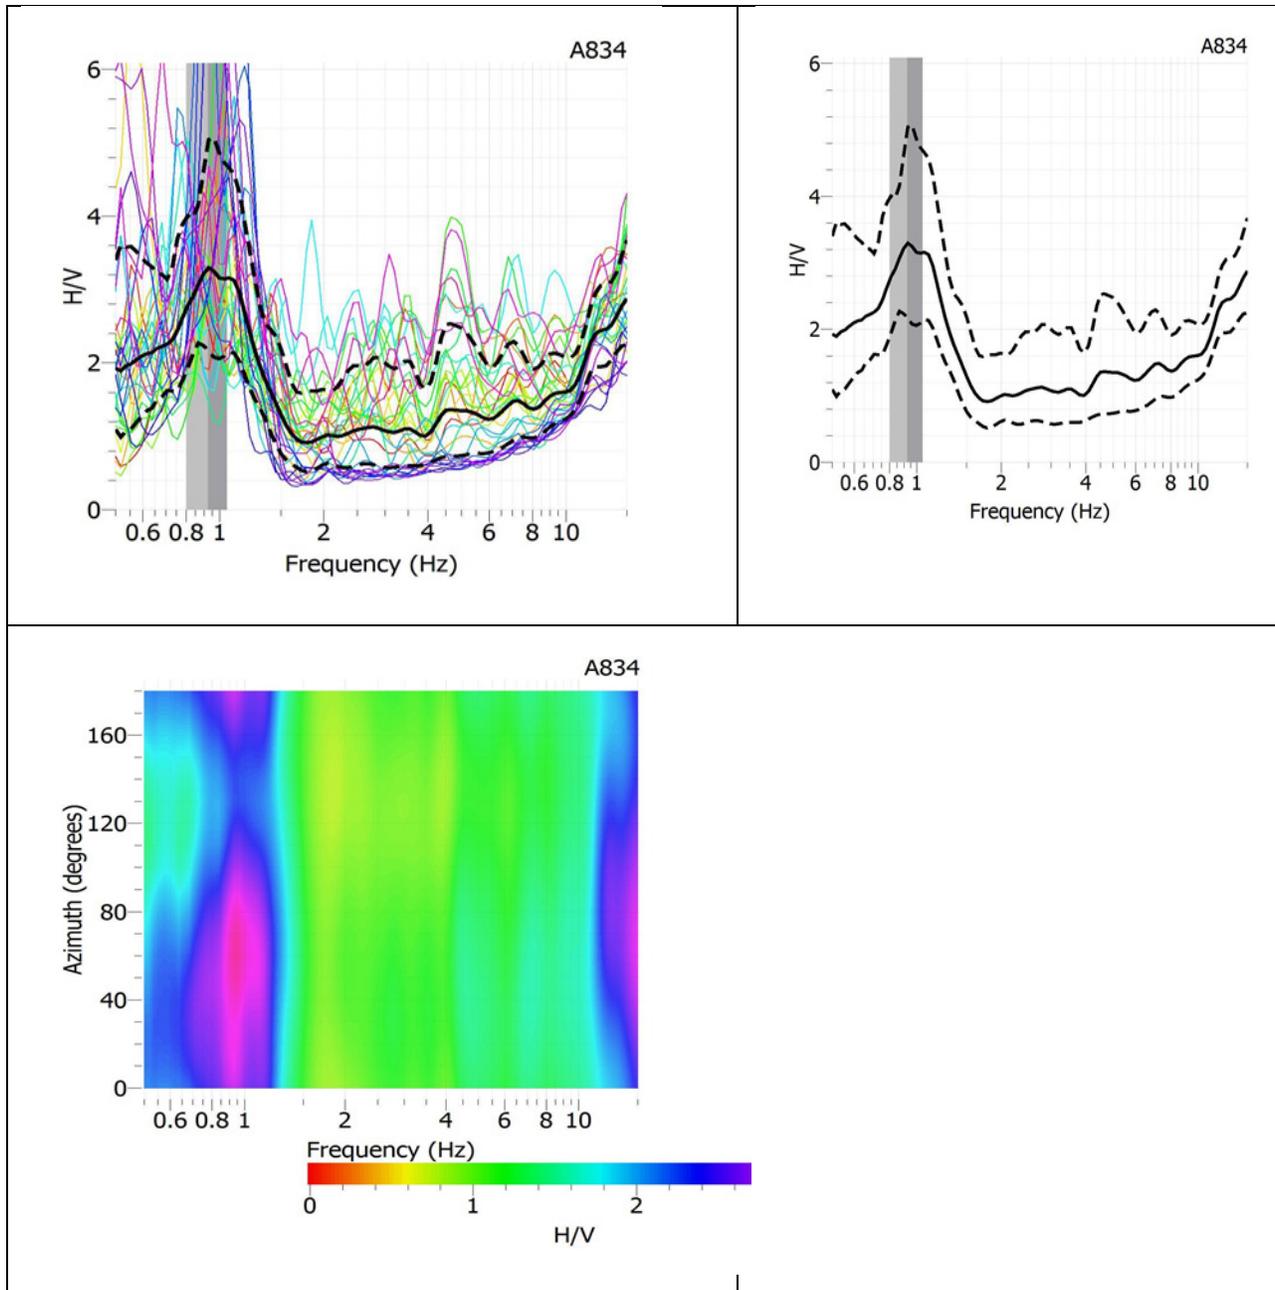
**Figure 6.21:** Seismometer measurement A834\_Feb24\_1700 with (a) individual H/V window peaks, (b) mean H/V peak at 0.950 Hz (corresponding depth: 293.3 m) and (c) H/V rotate analysis, indicating seismic sources that arrive from all directions.

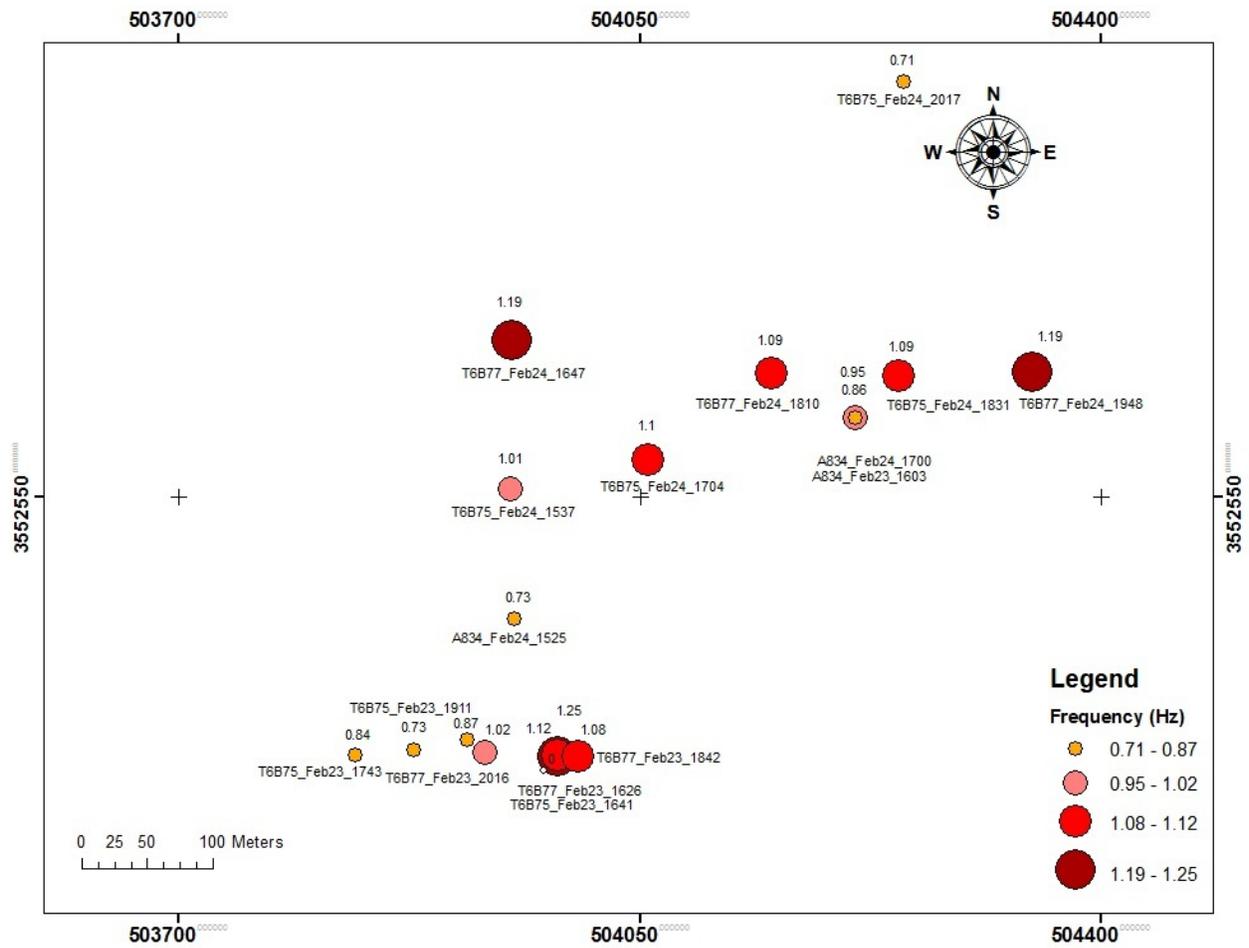
**Figure 6.22:** Frequency ranges in the seismic data with their corresponding seismometers.

The plateau and peak frequencies range corresponds to a depth of about 220 to 400 meters. According to Davidson (1973), this depth range in general correlates with tertiary Tinaja beds. However, the well data that is closest to the study site in F-F' cross section of the Davidson (1973) study does not contain any data for the depth of interest for this study. According to another study, this depth range might correlate with the transition between the upper and lower part of unit A of the Pliocene upper basin fill deposit (Houser & Gettings, 2000). Houser & Gettings (2000) describe the transition as gradational, which implies a low impedance contrast that agrees with low peak or plateau amplitudes of approximately 2. In addition, the calculated depth was derived from a few assumptions, including the Poisson's ratio and the P-wave velocity, which was derived from an area in the Tucson Basin close to, but not on the study site. This offset between the survey location with the Exxon 32-1 Well and the reflection seismic lines locations might explain the mismatch.

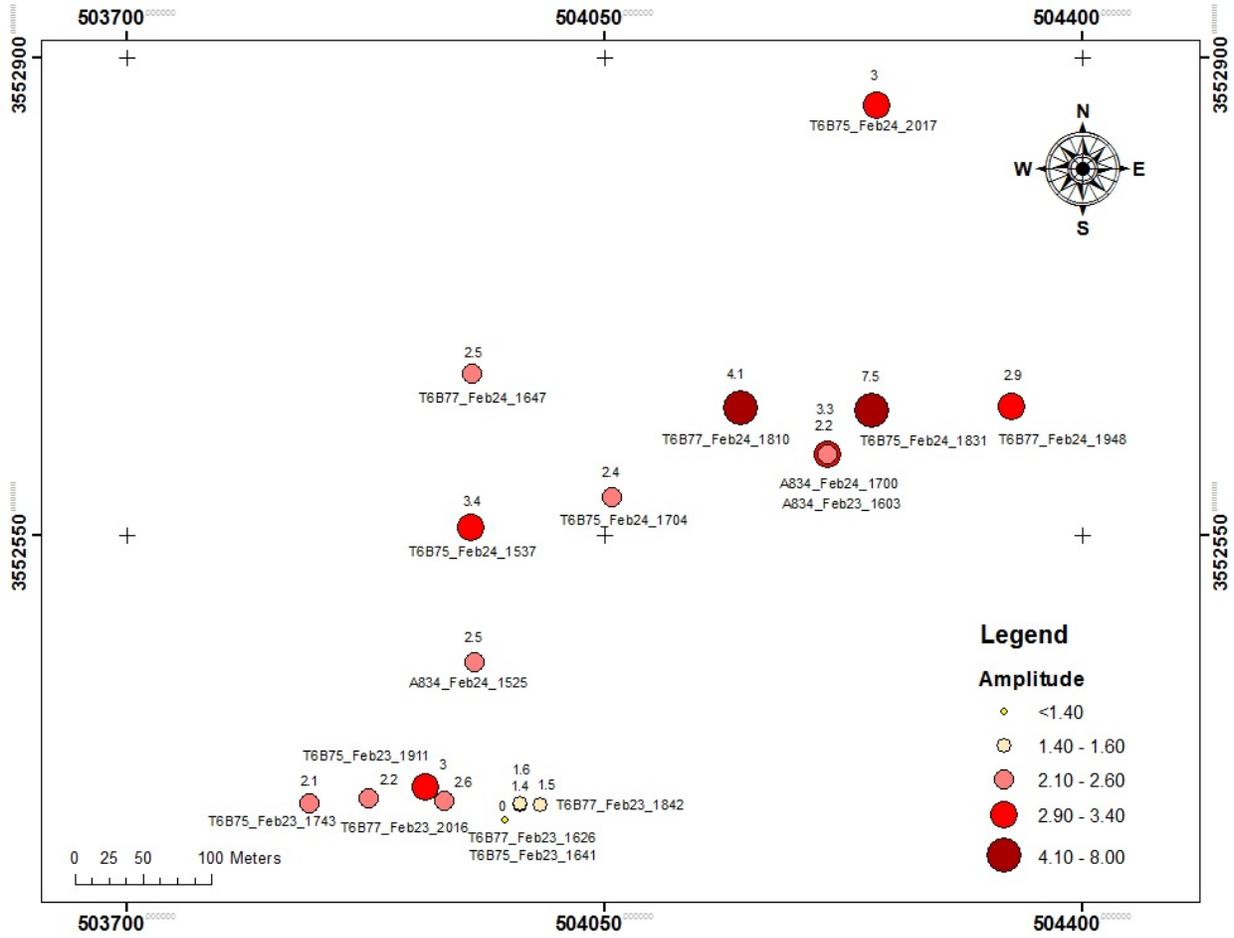
Figure 6.23: Amplitude ranges in the seismic data with their corresponding seismometers.

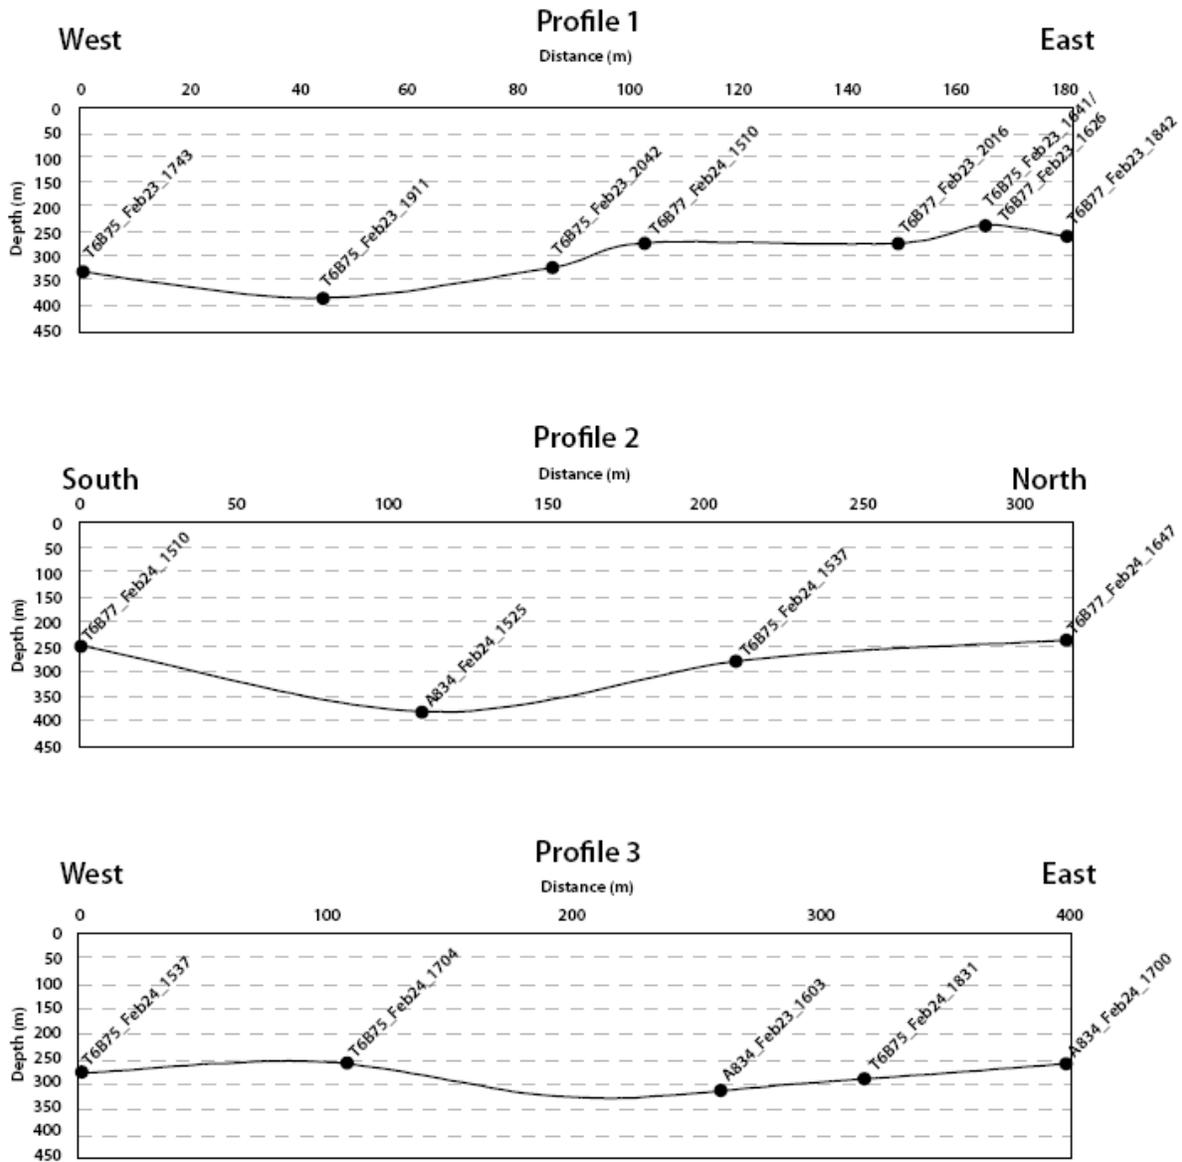
**Figure 6.24:** Seismic profiles 1-3 with the corresponding seismometers used in the profile generation. Profiles 1 and 2 can be referenced in the aerial map in Figure 6.1, and Profile 3 can be seen in Figure 6.2.
